Inspection Report

Homemasters Building And Pest Inspections

Sample Report Street Adelaide, sample

Pest And Building Inspection

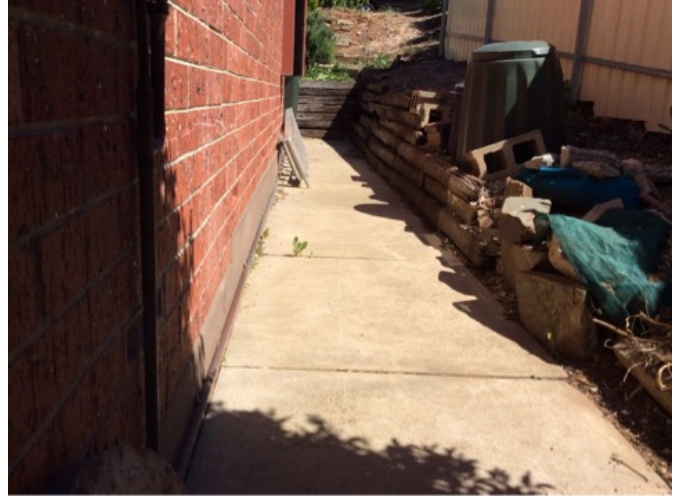
The paths at the side of the property are incomplete. Contact a licensed landscaper for advice and recommendations.

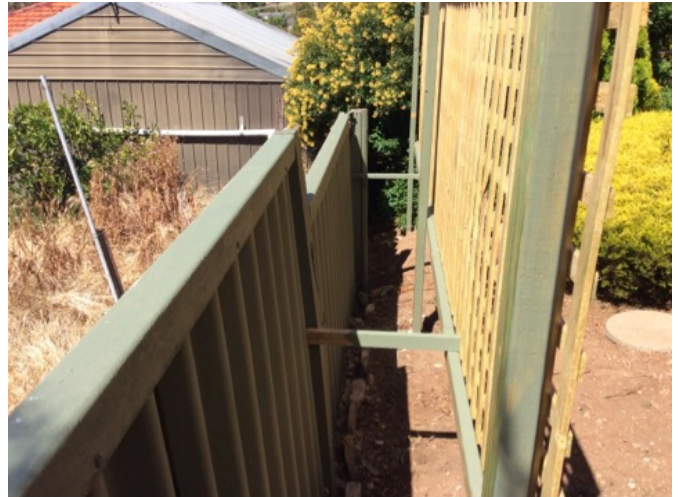
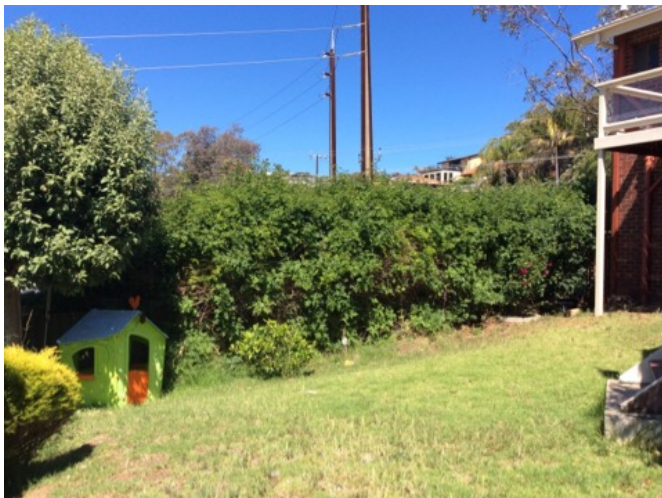
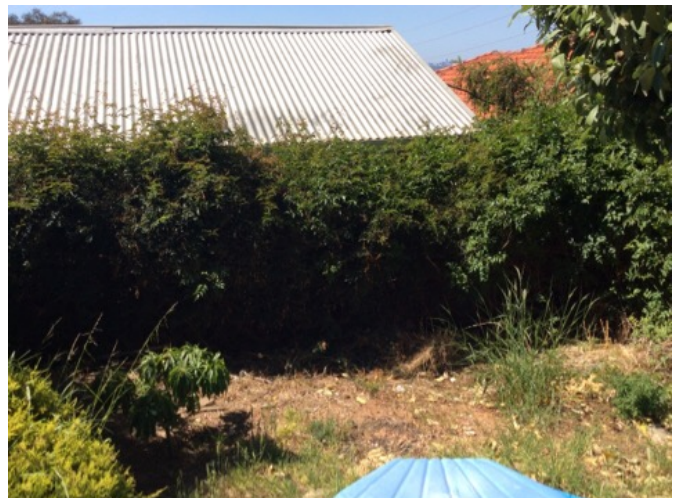
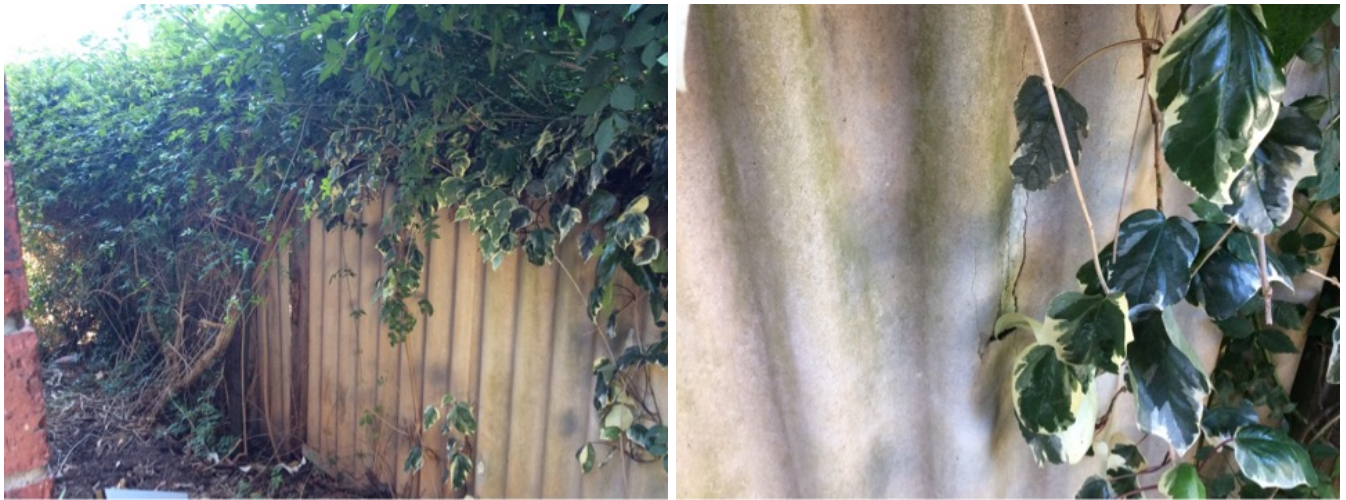
Vines present, recommend immediate removal as this can cause additional stress to panels and cause early failure. Vines may also be holding up sections of fencing, some leaning to areas is present.

Dirt against panels, recommend immediately removing any soil against the panels to help prevent early deterioration/rust. Fencing should not be used to retain soil, ideally a small plinth or retaining wall should have been installed to areas as required and the fence installed on top of that. All vines should be removed so a store complete inspection can be undertaken.

Rear and right hand side fencing is asbestos. Consult an asbestos specialist for advice and recommendations. Some damage to panels as can be seen in the last photo.

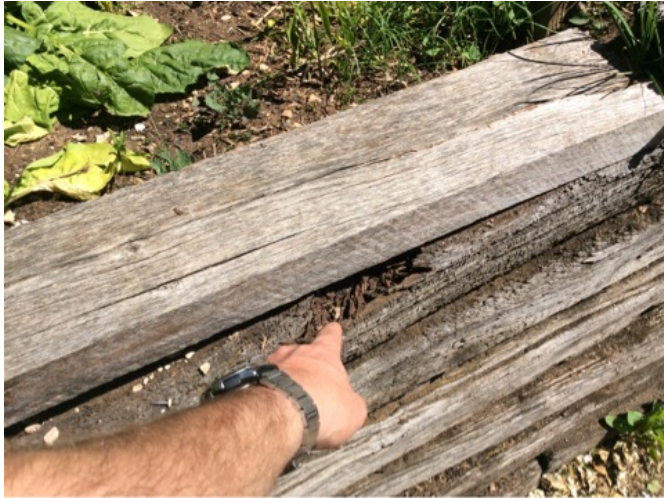
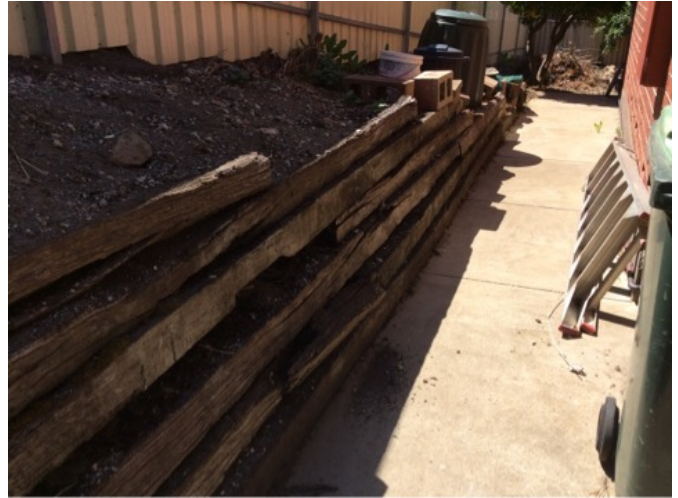
Timber fungal decay evident. Recommendations: A qualified landscaping contractor should be engaged for repairs and recommendations. Ideally should be replaced with concrete.

Termite damage noted. We recommend you contact a licensed pest controller for further assessment, treatment and eradication in accord with AS3660.2

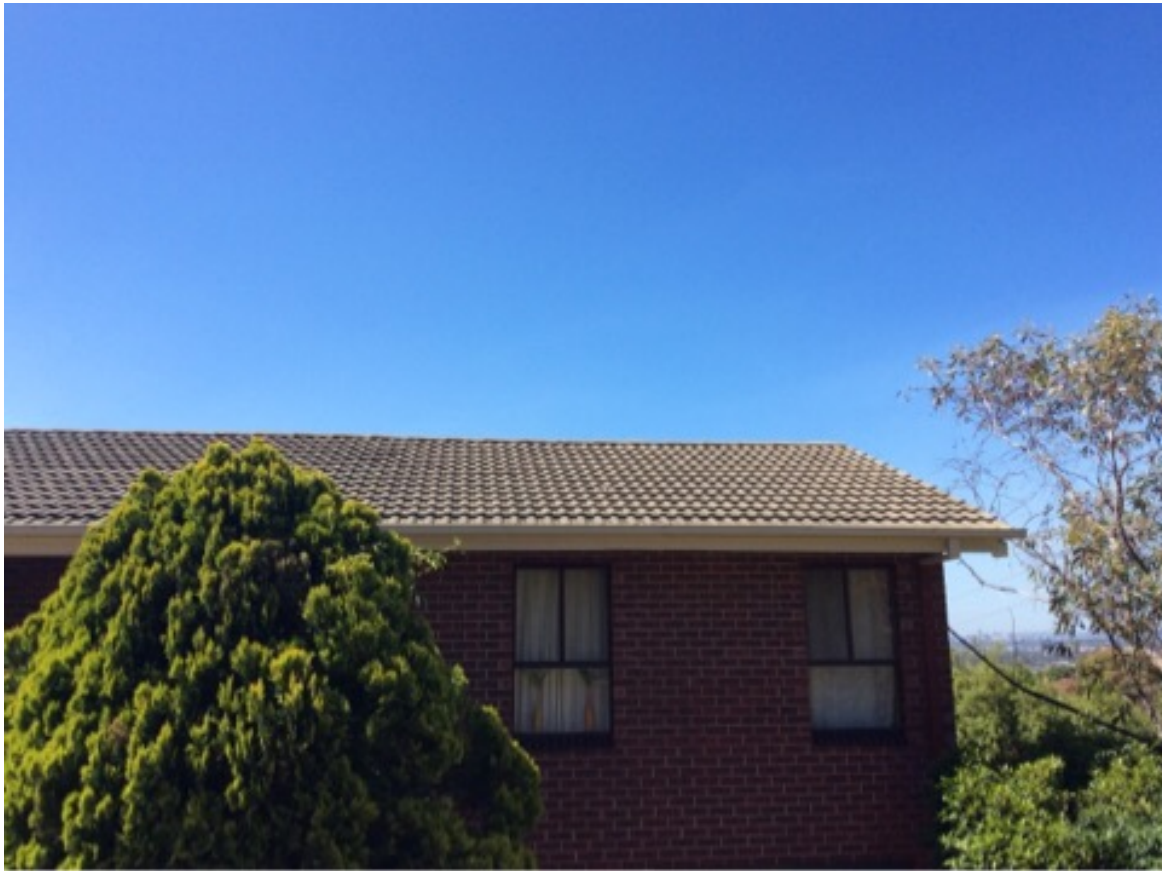
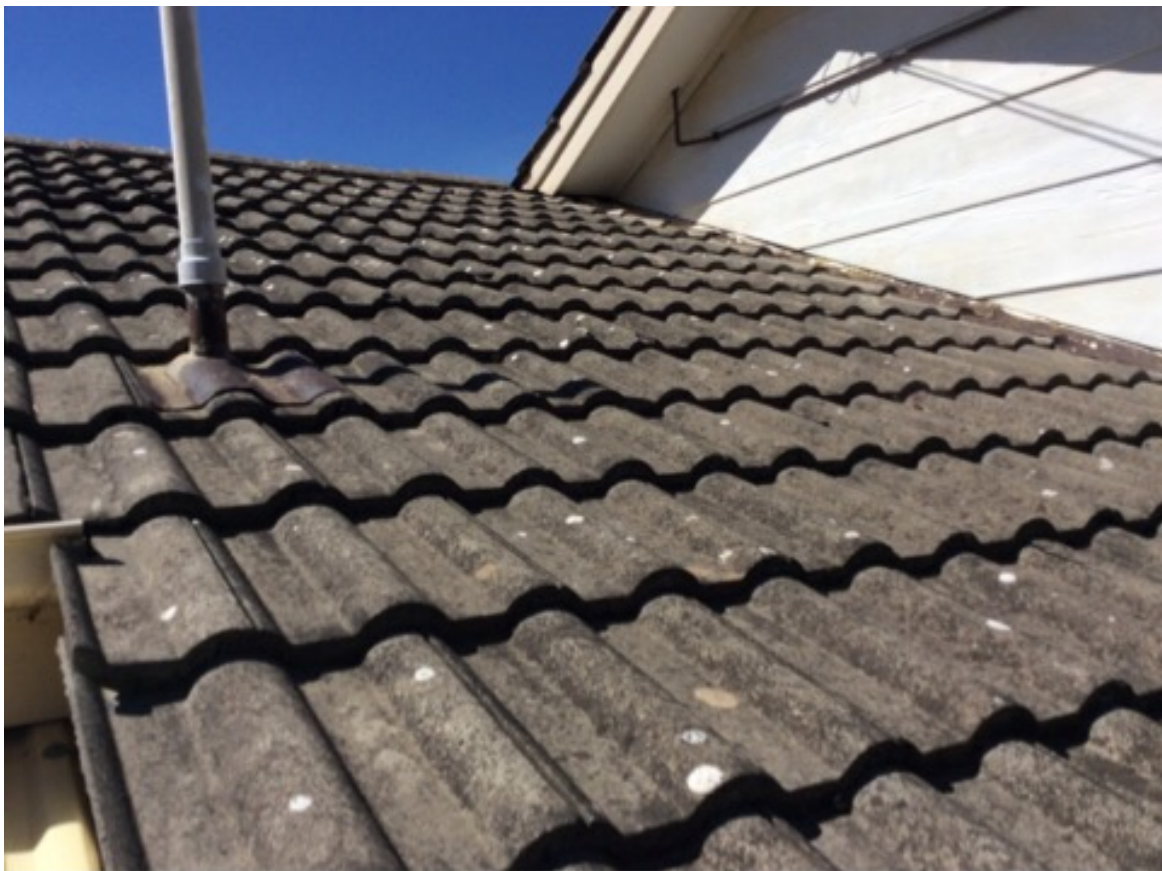
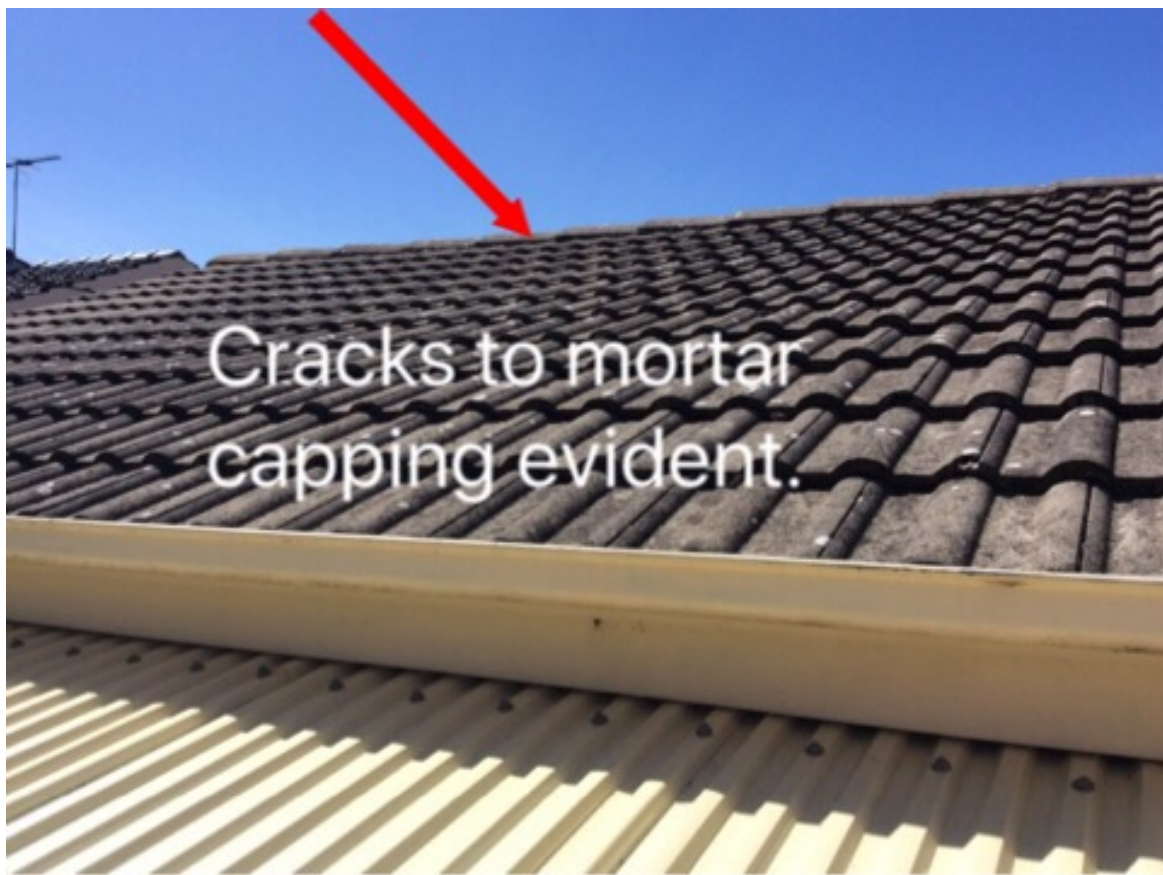
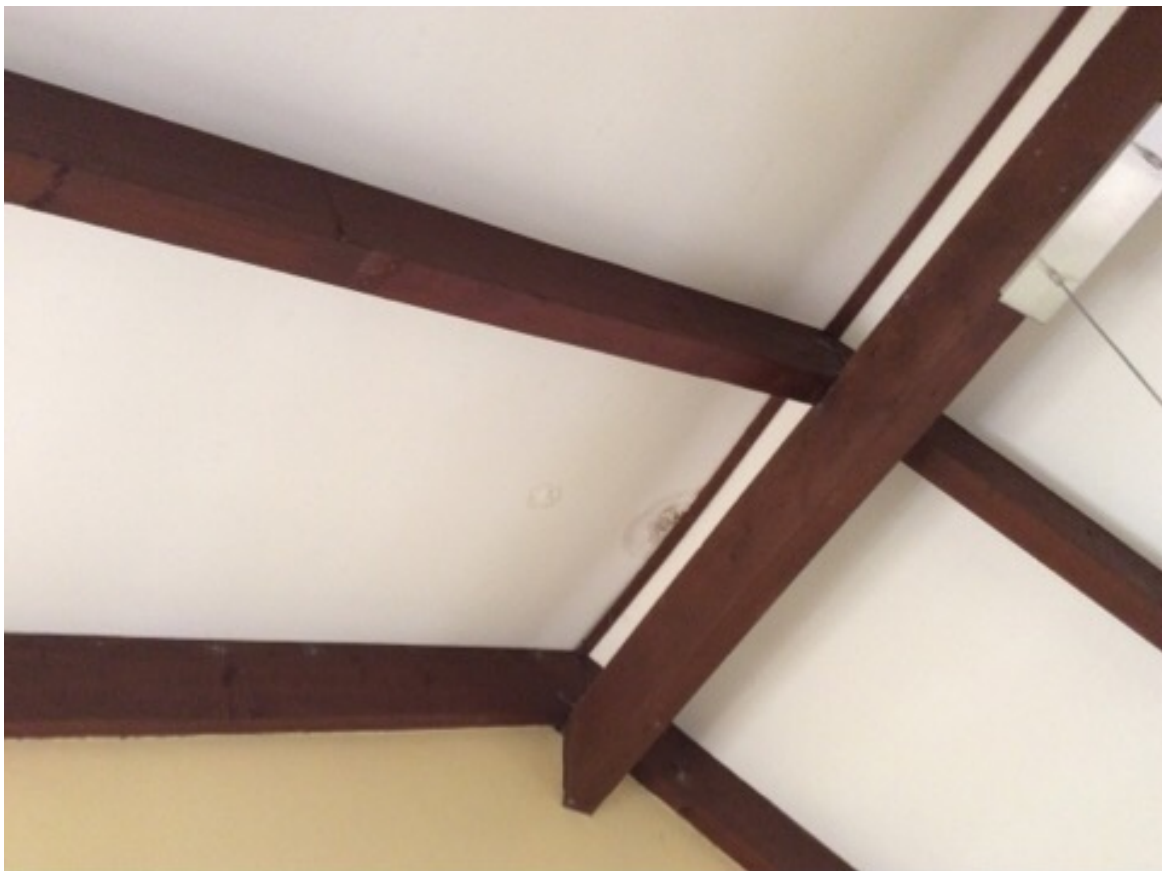
Multiple active leaks identified inside the home, recommend a full inspection of roof covering is performed. Safety harness due to height is required. Defects most likely exist in not accessible areas.

Some areas Not inspected as too high to reach by ladder. Viewed from a distance only.

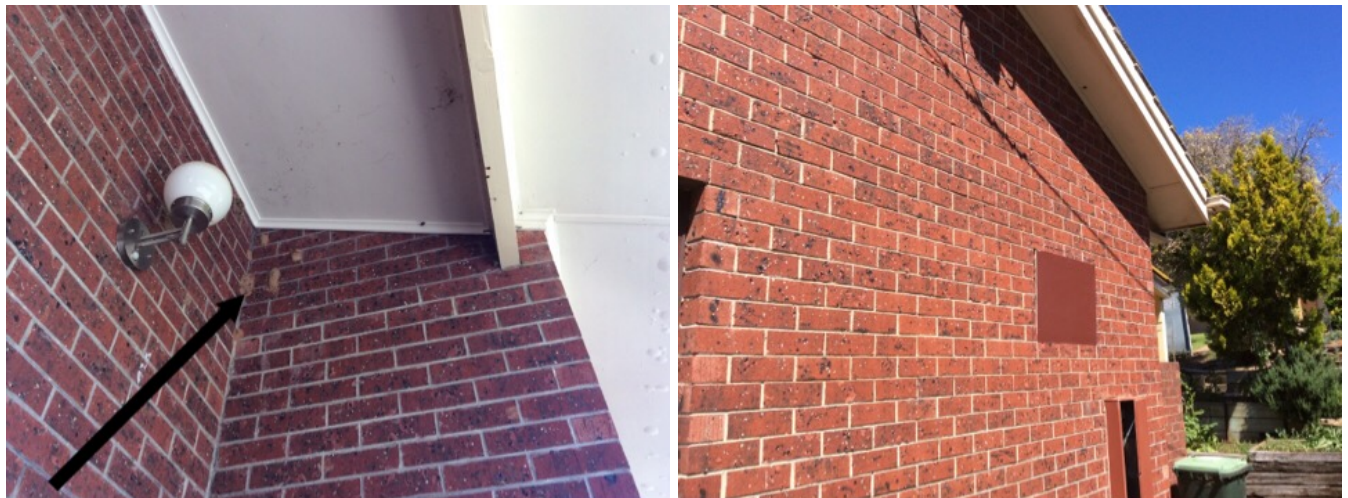
Wasps nest noted under front porch area, consult a pest technician for treatment.

Area where old air conditioner would of been has been poorly boarded up. May allow water entry. Rectify. Remove all vine growth to the walls immediately.

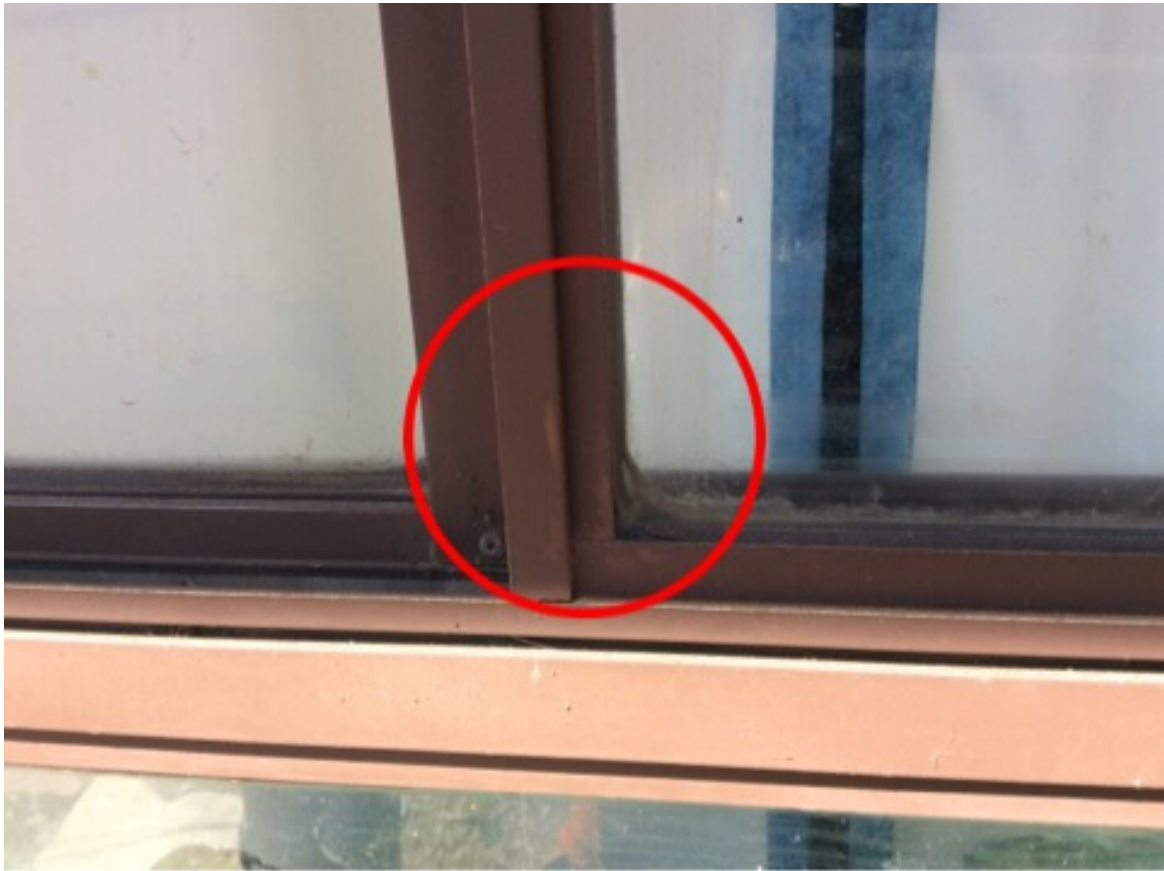
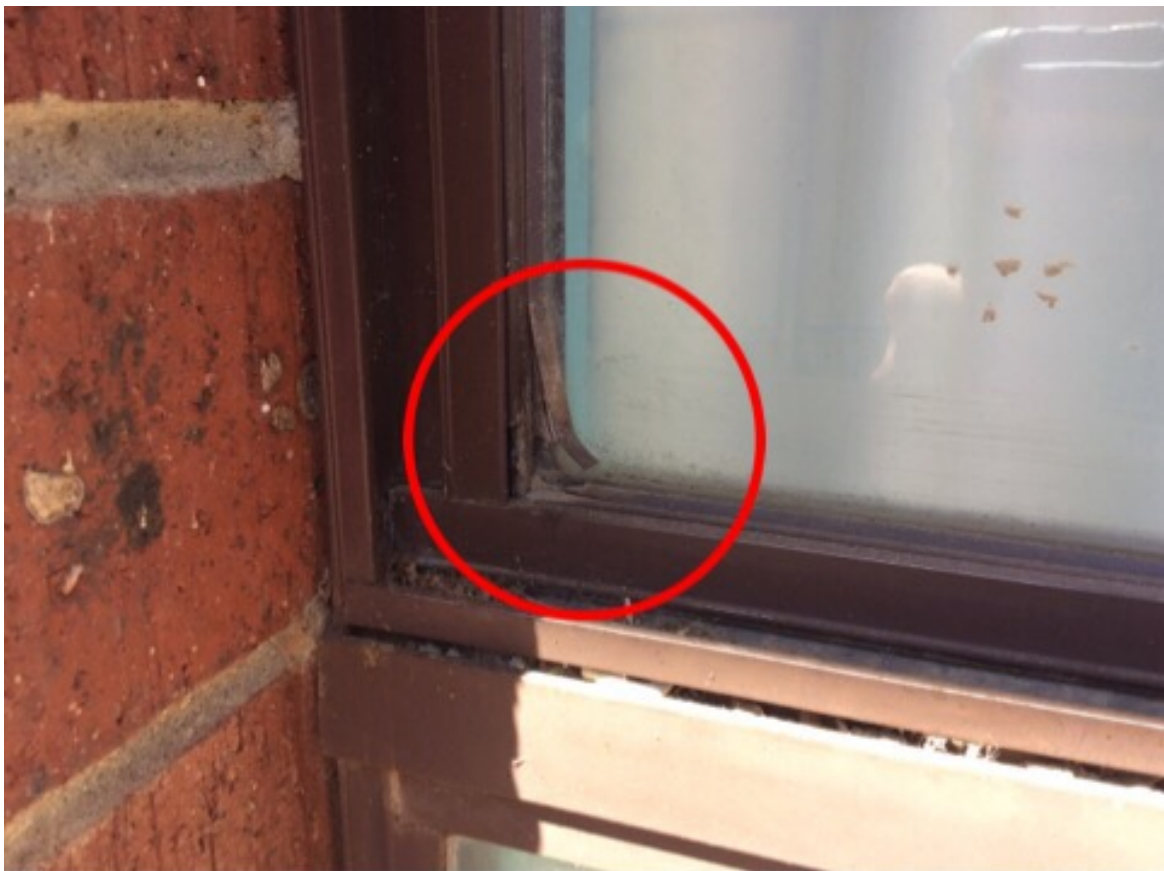
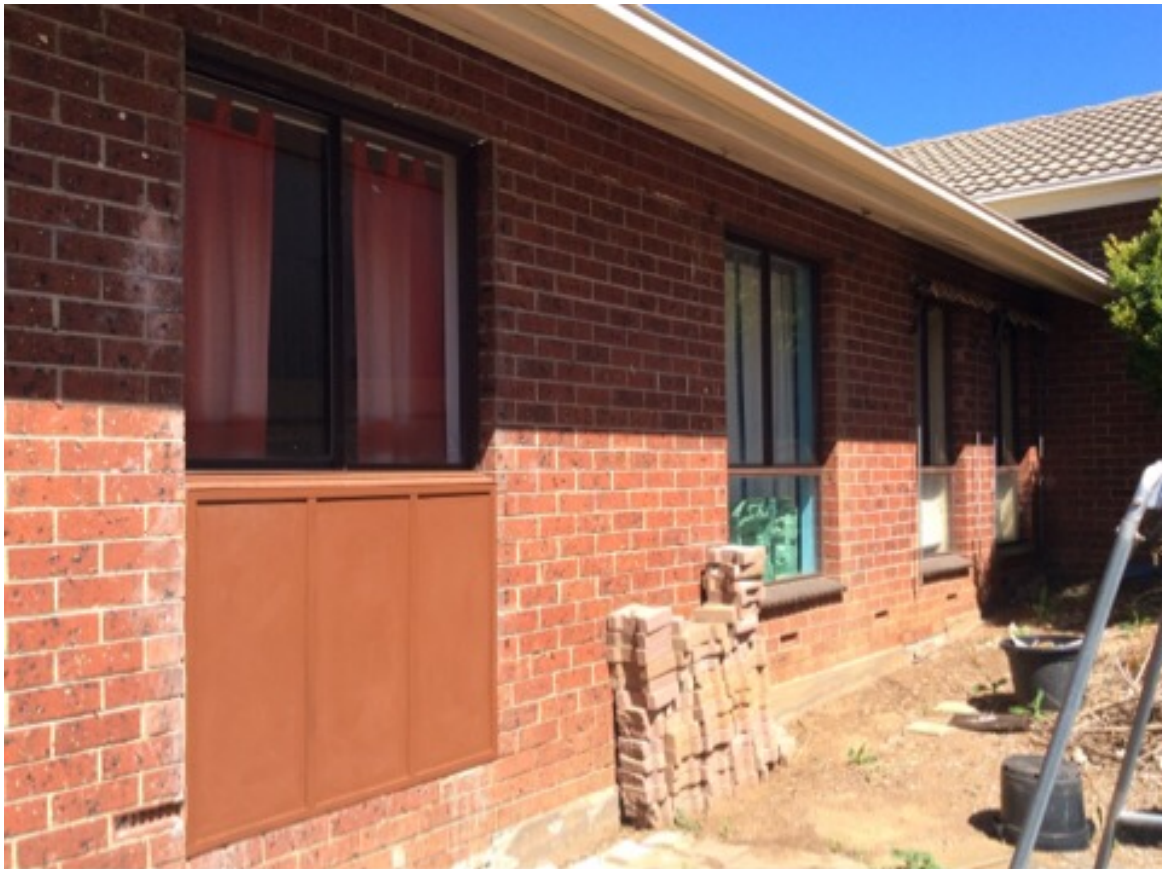
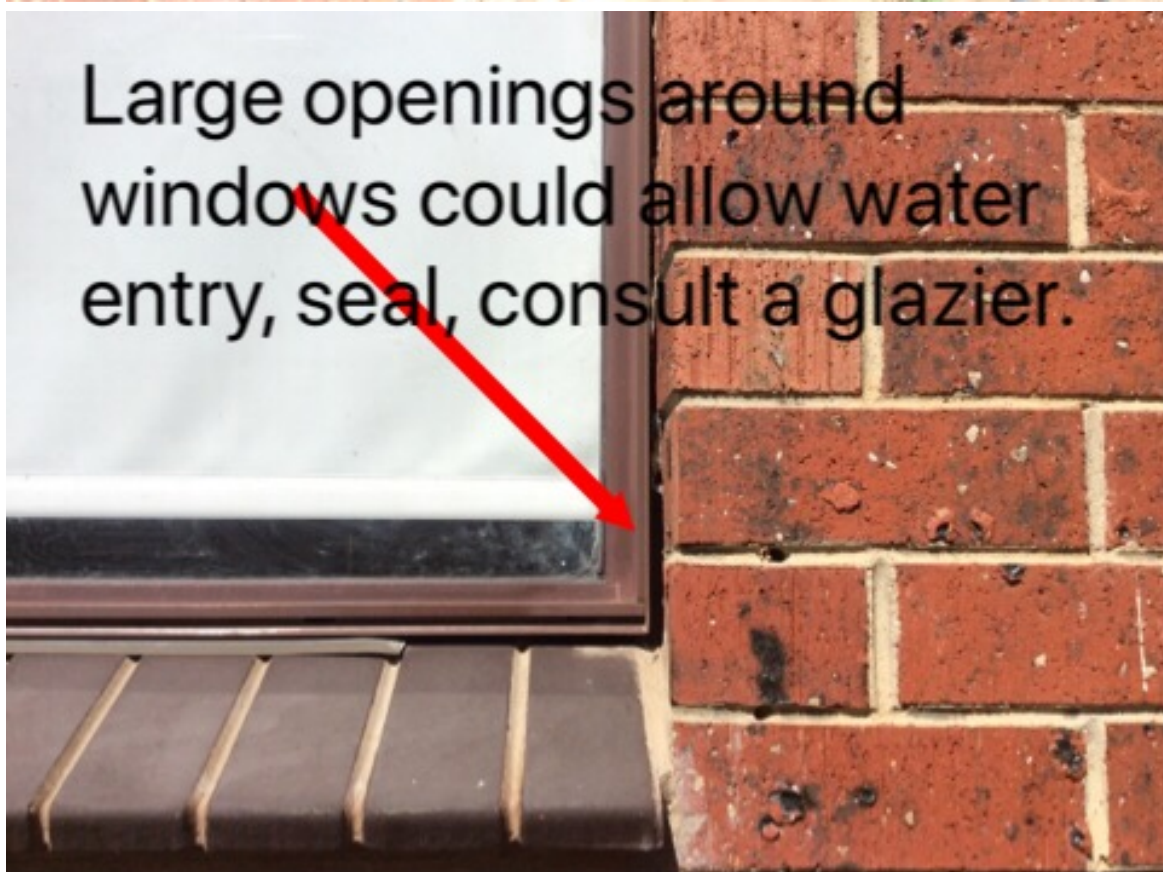
General age/damage has occurred to window components. Recommendations: Restoration work recommended. A qualified carpenter should be engaged for advice and recommendations. Seals are worn due to age, check after rain for water ingress. If it occurs consult a glazier.

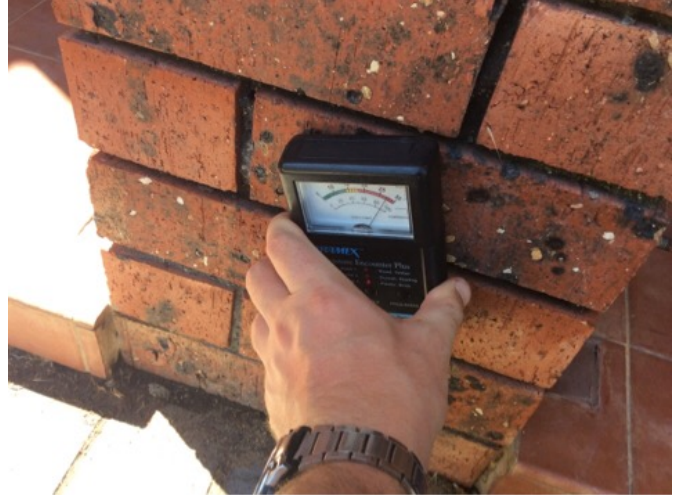
High moisture readings were to the exterior walls, support columns and front wall. We recommend a damp proof course specialist be engaged for further evaluation and repairs. Fretting if mortar was evident. No major deterioration to bricks was observed.

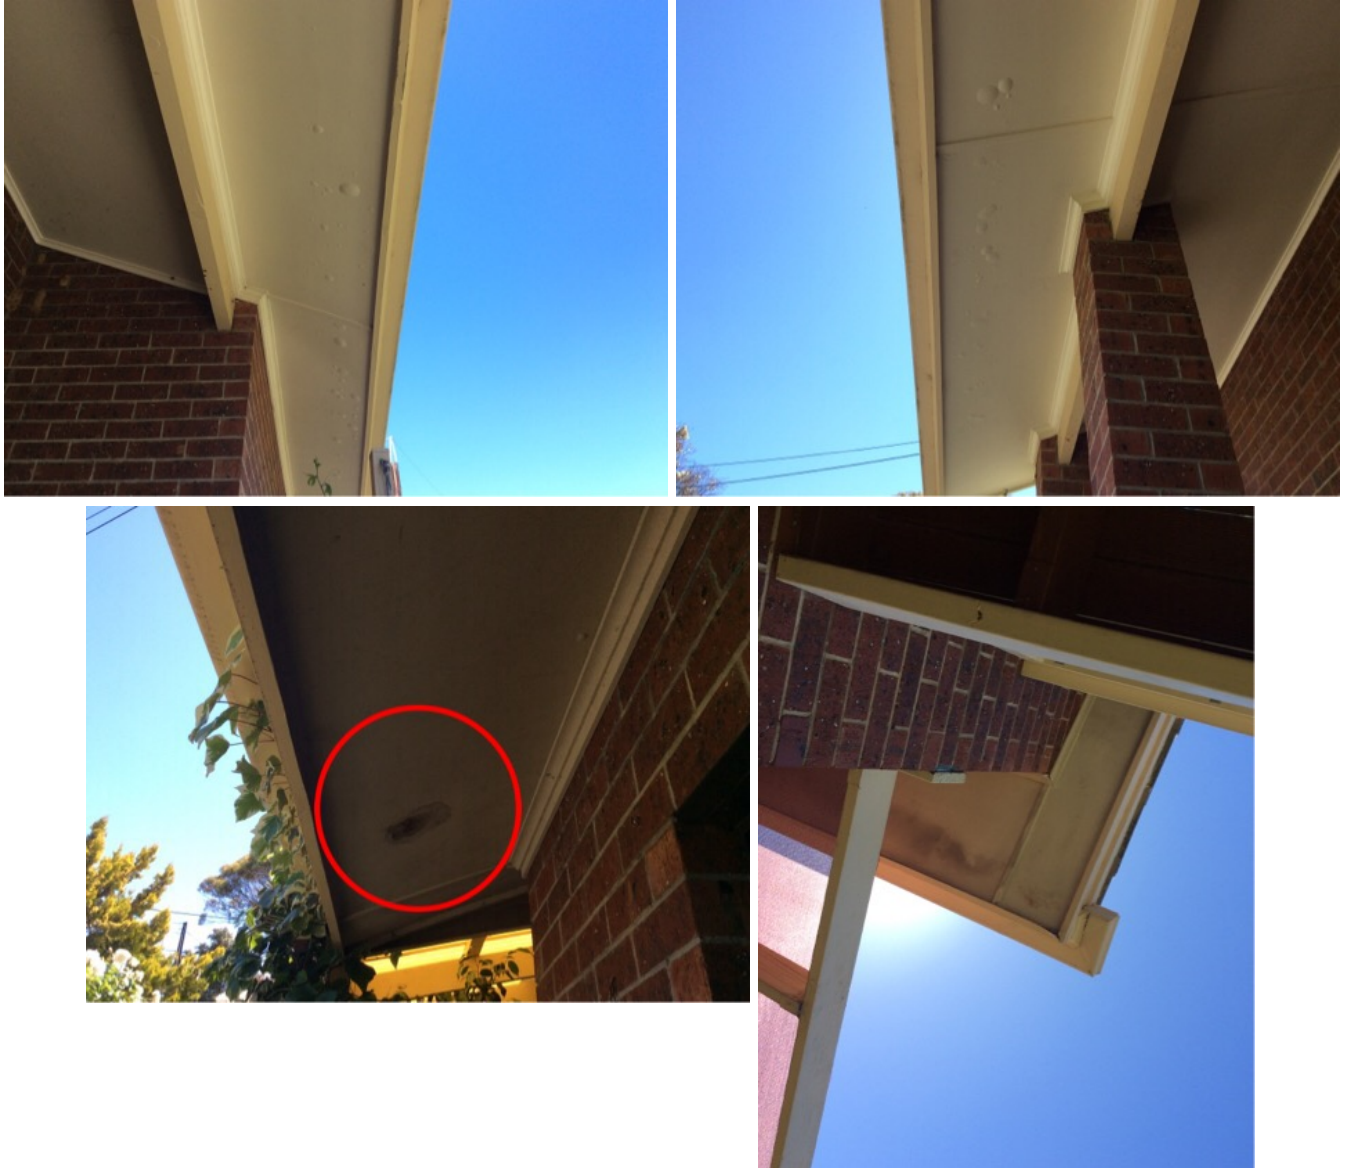
Minor eave deterioration & ageing evident. Recommendations: Maintenance works, general upkeep should be carried out.

Paint flake/bubbling/deterioration is evident. Recommendations: General maintenance / painting as required.

Eave lining stains observed. Normally this occurs due to overflow in blocked gutters. Recommendations. Gutters should be kept clear of debris and eave linings can then be painted or repaired as required.

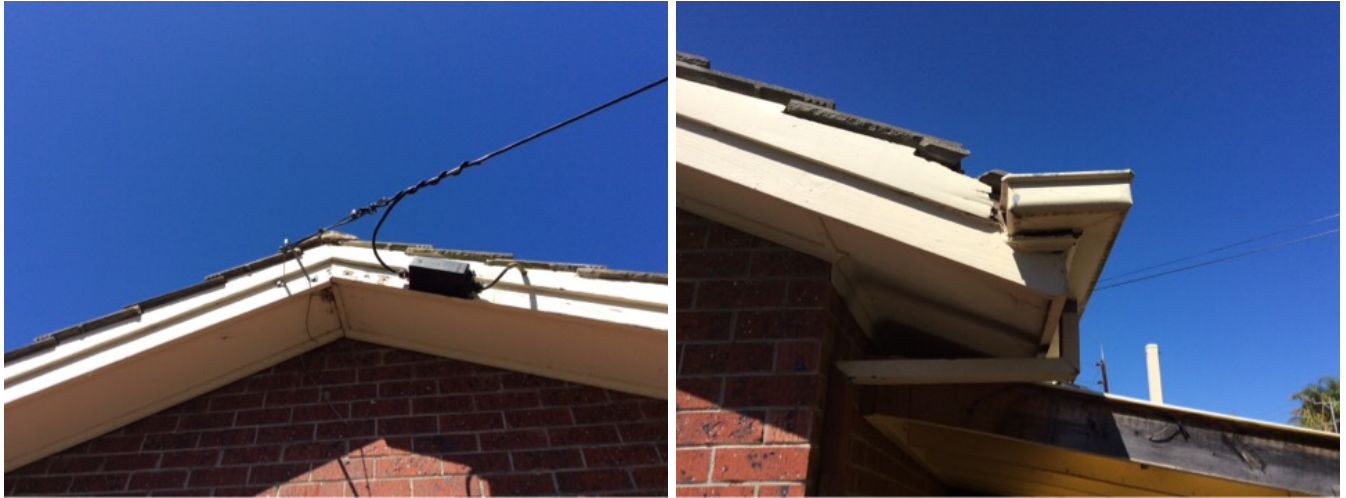
Paint / finish was deteriorated in areas and is in need of maintenance - Sanding back affected areas and painting required.

Timber fungal decay (rot) visible. Recommendations: A qualified carpenter should be engaged to replace all affected timbers.

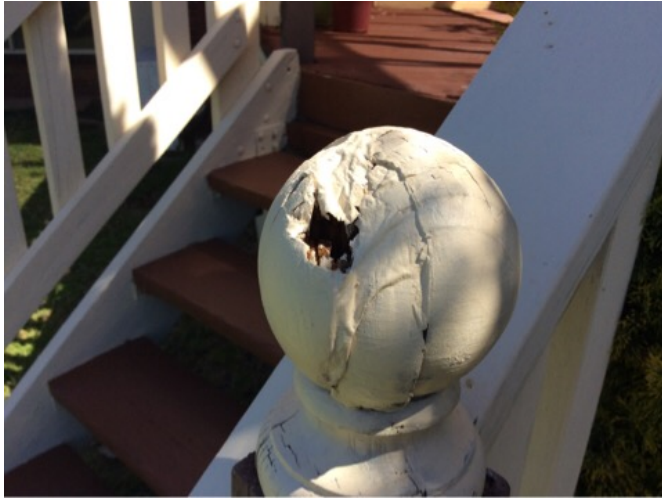
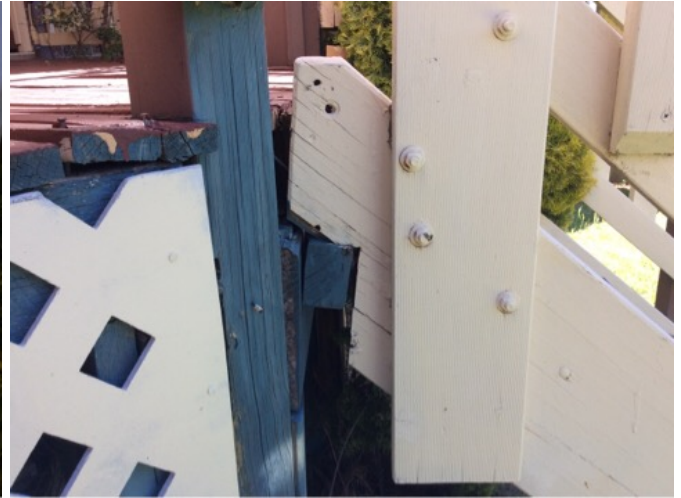
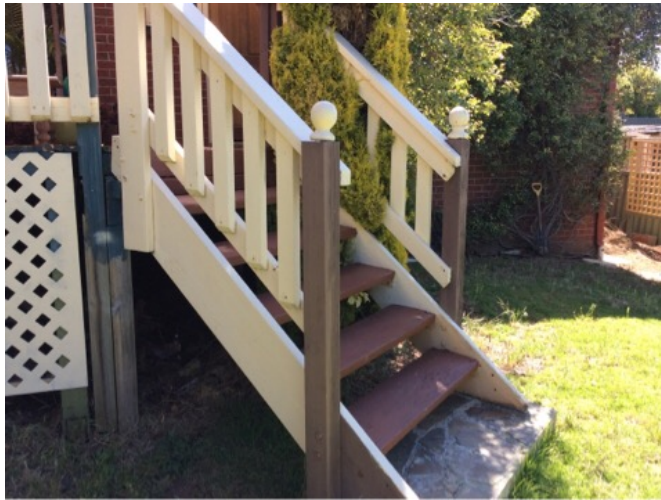
Timber fungal decay in sections. This is a safety hazard and repair is required -

Recommendations: A qualified carpenter should be engaged for advice and recommendations. Joints and separation occurring, handrail can also be moved easily, recommend rebuild.

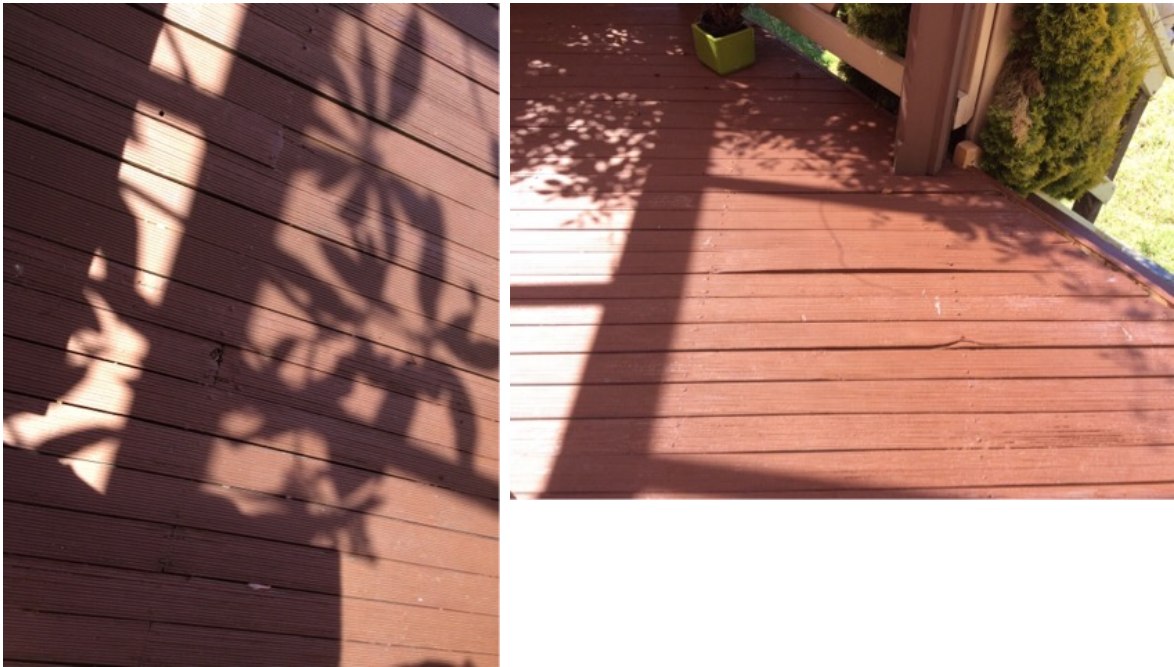
Deck board have been laid upside down which was common some time back for grip reasons. As is, the grooved face will expedite rot due to water in the grooves. Recommendations: Upkeep / maintenance or turning.

Decking board surfaces are weathered - Recommendations: We recommend cleaning and maintenance as needed. Some areas have lifted causing a potential trip hazard. Decking is not level.

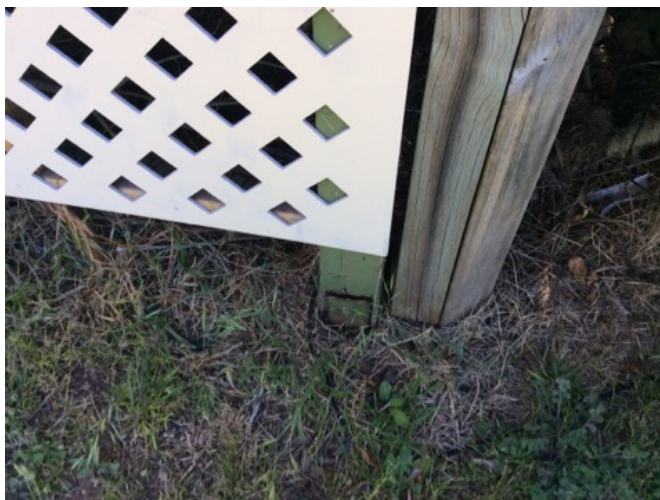
Post base timber fungal decay- recommendations: Repairs as required. It is preferable to have posts on stirrups kept out of contact with soil. Timber in contact with ground is conducive to termite infestation and timber fungal decay.

Rust evident in area/s. Recommendations: Have assessed by contractor with view of restricting/repairing and sealing affected areas.

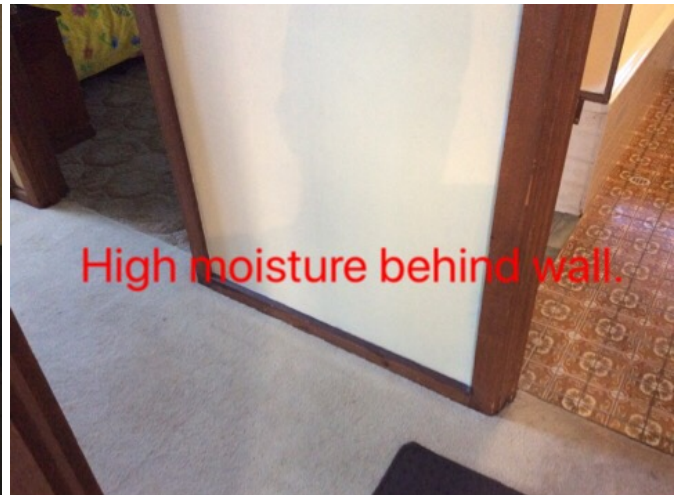
Settlement Cracks Noted. These are typical and generally patch and paint will suffice, however we recommend monitor these cracks and if become wider or longer, you will need to contact a structural engineers to assess.

Excess moisture readings were obtained on the wall linings adjacent bathroom/shower. This may be related to the shower recess/plumbing in wall cavity leaking or failed waterproofing membrane to the wet area. Recommendations: Engage a plumber and a licensed waterproofer for advice and recommendations.

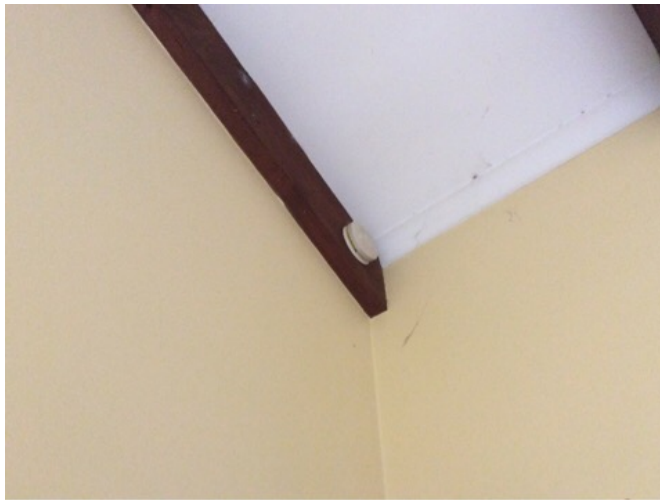
Yes a smoke alarm was sighted but not tested.

Legislation requires smoke Alarms to be installed. Check with your local council regarding type, locations and other related requirements. Appears quite old.

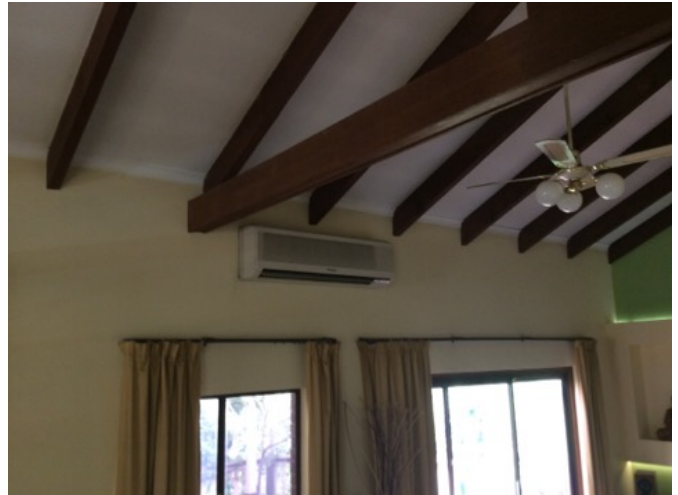
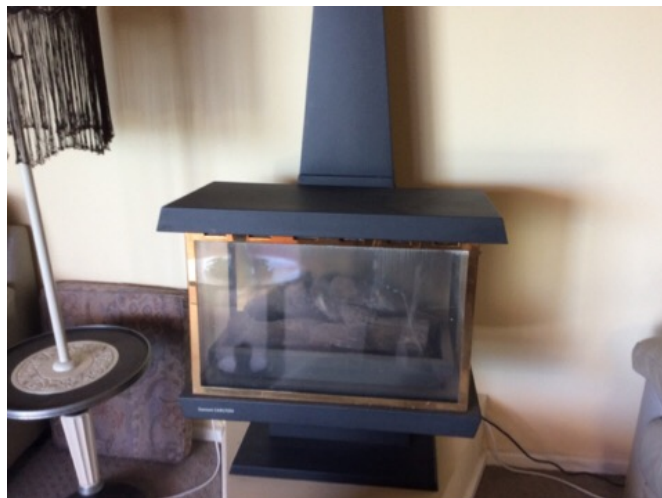
Mounted tv, may leave damage when taken. Ask for mount.

Panasonic air conditioner working but quite noisy. Consult a specialist to assess and provide recommendations.

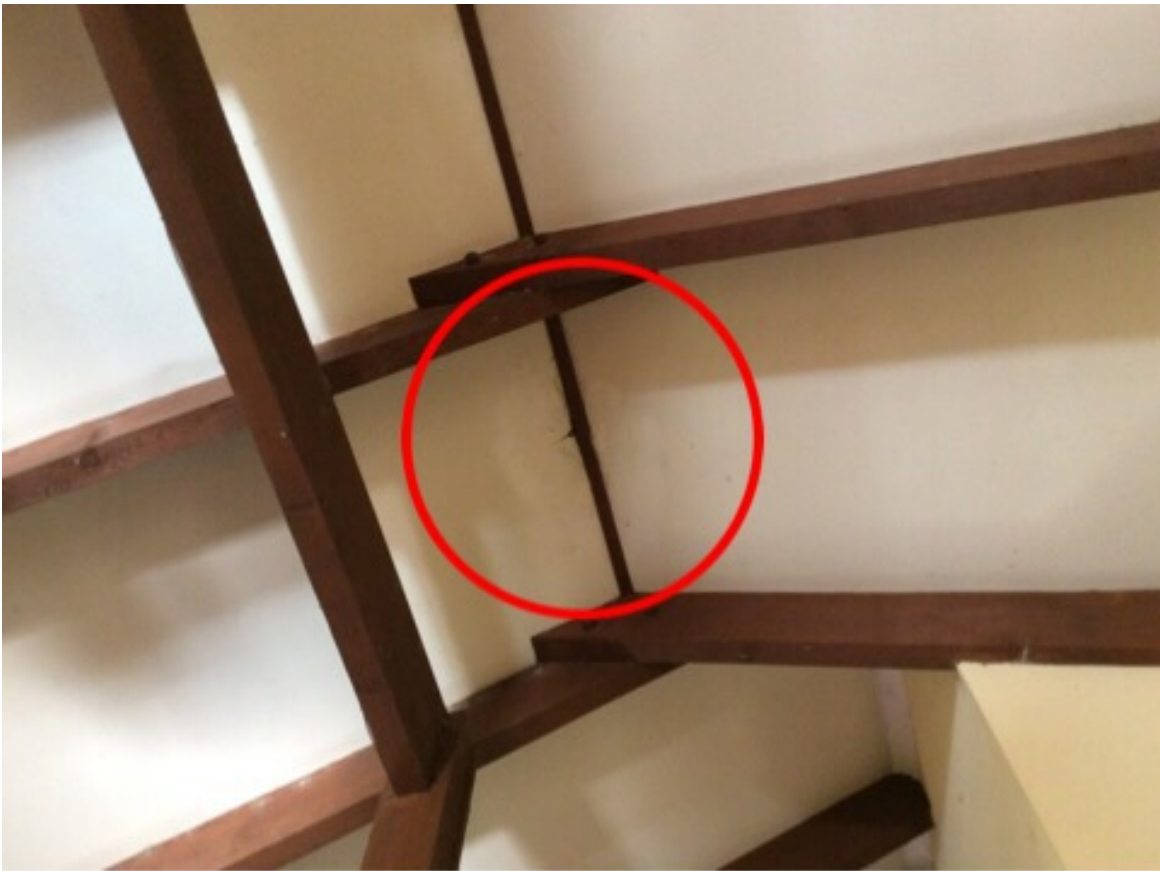
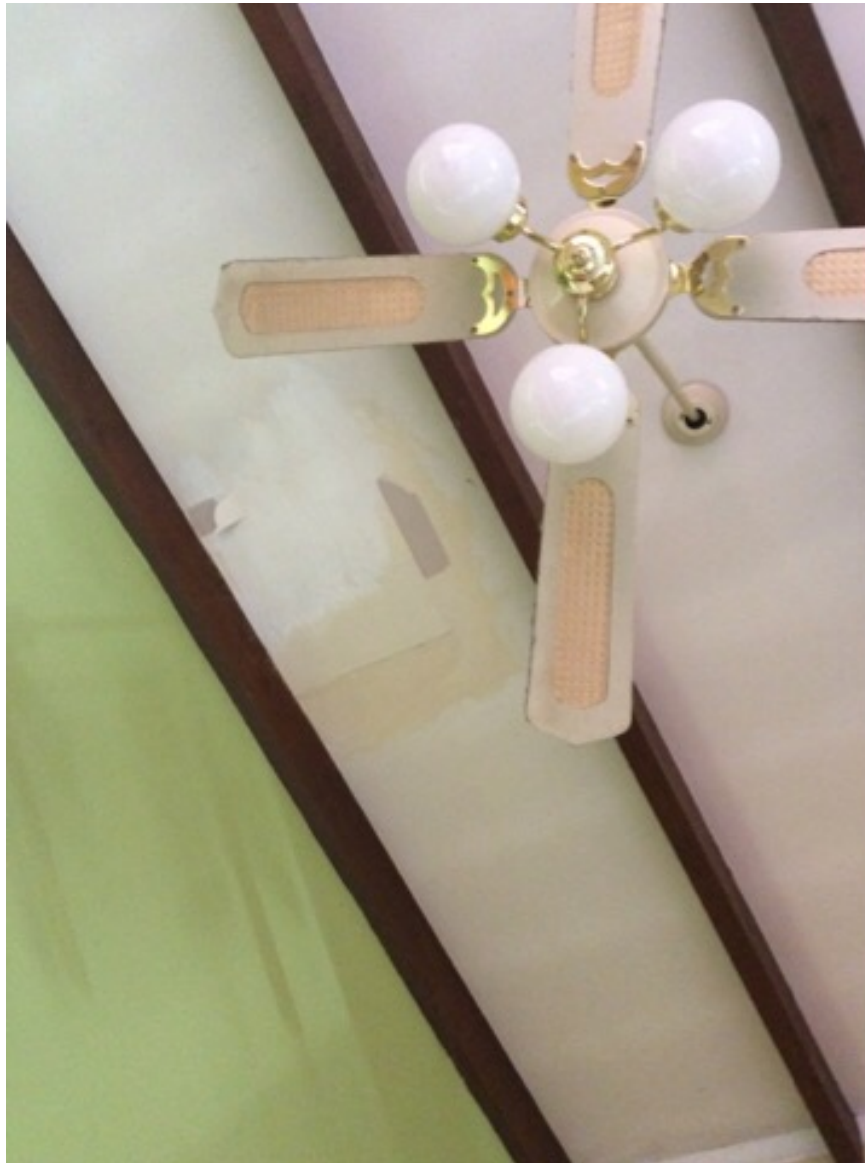
Ceiling stains - No moisture readings obtained. Recommendations: These may have been repaired, however, you will need to monitor after a prolonged period of rainfall - If leaking persists, a qualified plumber should be engaged for advice and recommendations. All water damaged plaster replaced by a qualified plasterer.

Area has been patched, large square cut. Unfinished and requires maintenance.

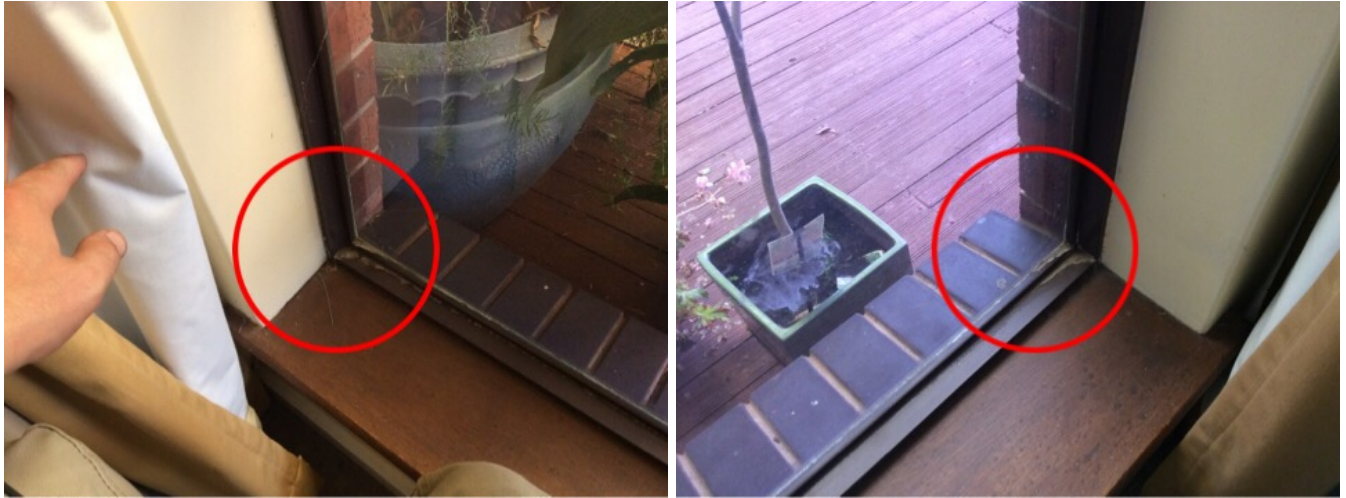
Moisture damage and high moisture readings recorded. Possible water ingress. Or condensation. Contact a glazier for repairs.

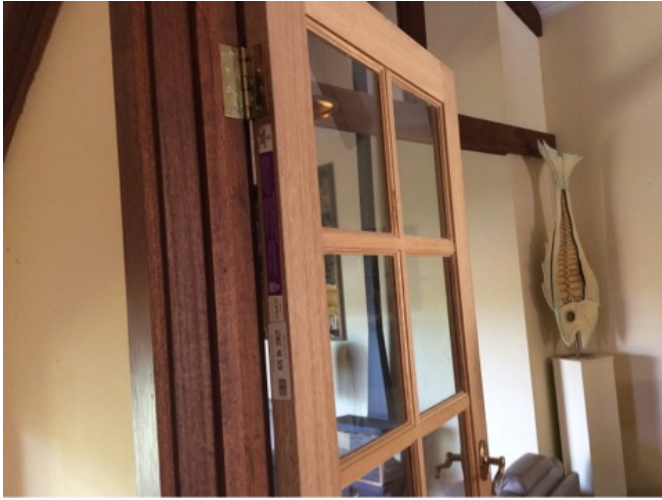
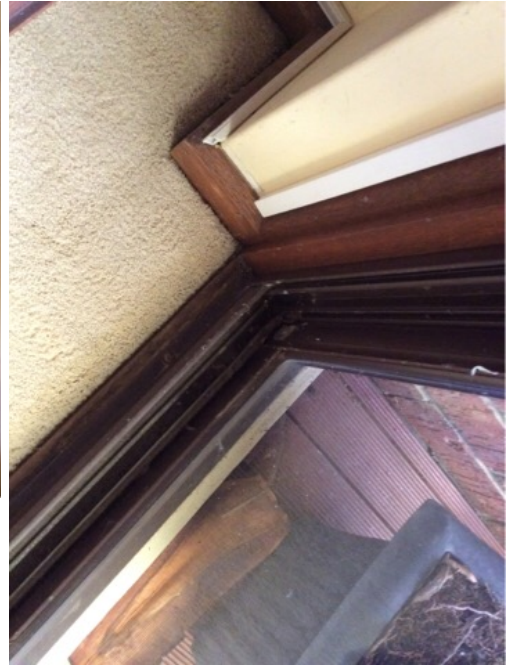
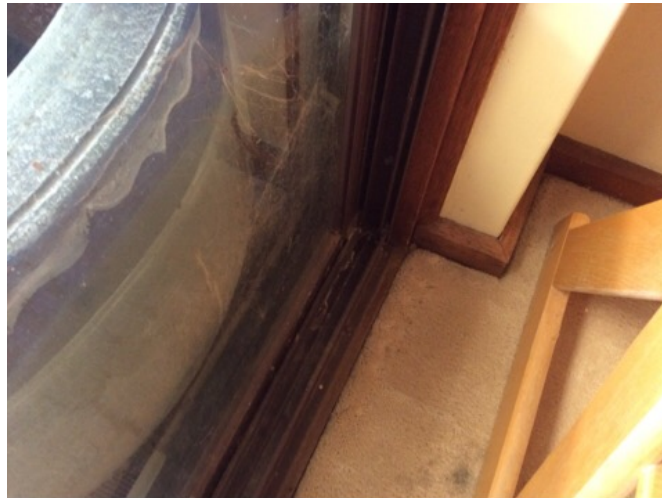
Brand new unpainted. Water ingress through sliding door. Consult a specialist for advice and recommendations.
