Inspection Report

Homemasters Building And Pest Inspections

Sample Report Street Adelaide, sample

Pest And Building Inspection

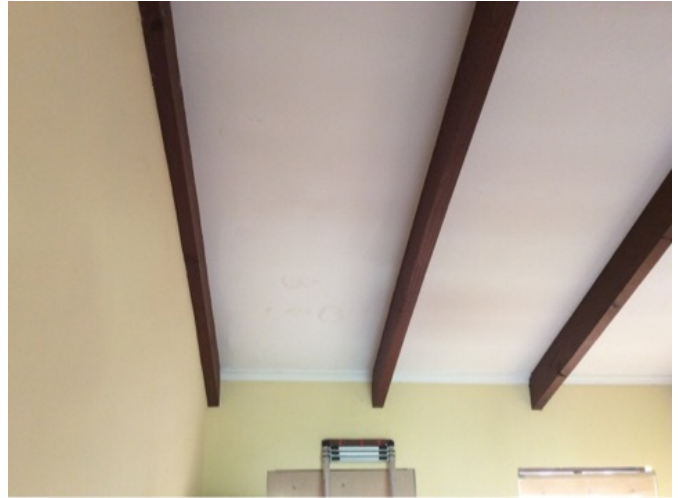
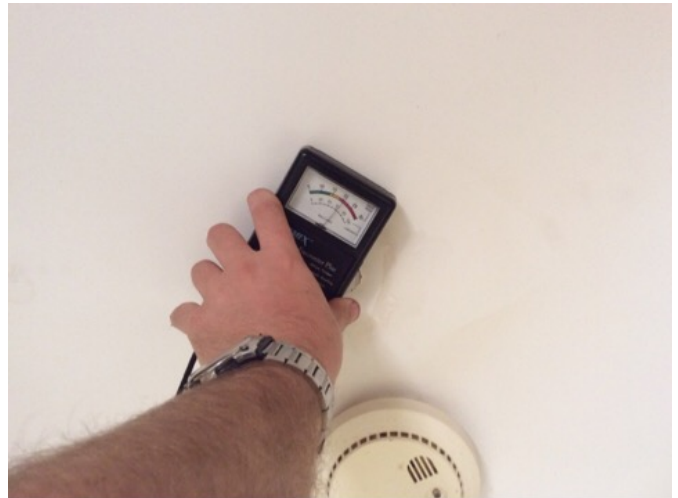
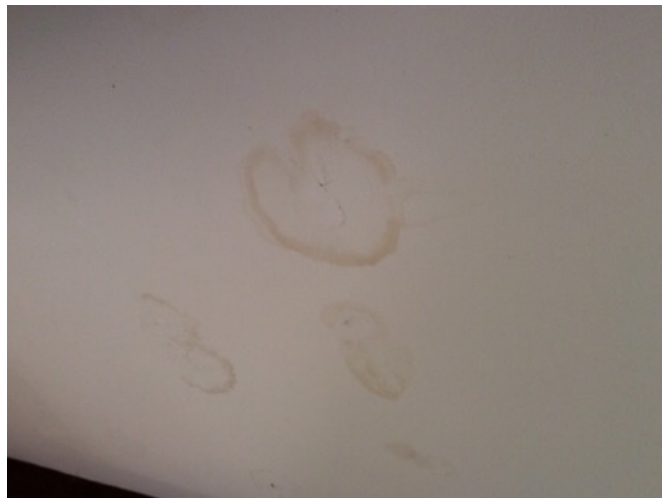
Ceiling stains - Moisture readings obtained. In the absence of rain It's difficult to ascertain with certainty the location of the leak. Recommendations: A qualified roofer should be engaged for advice and recommendations. All water damaged plaster should be replaced by a qualified plasterer.

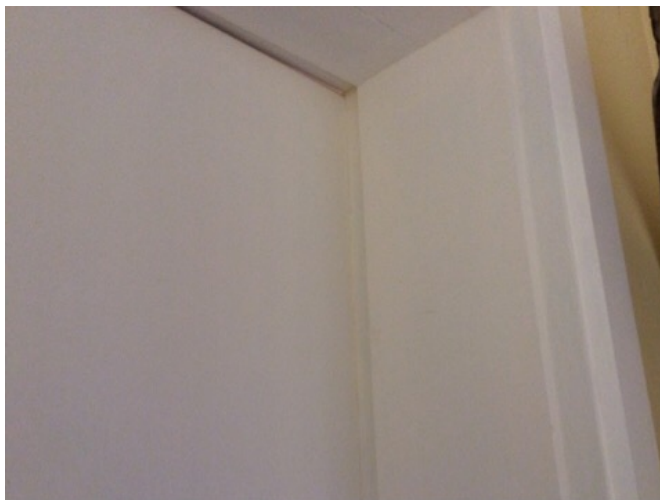
Binding door - Doors that bind on the frame can relate to some differential settlement in the footings, frame movement, age, expansion, shrinkage and the like. It can also be seasonal where it may bind for some months and then open and close sufficiently. Monitoring over time or a more invasive inspection is only method of ascertain cause. Recommendations: A qualified carpenter should be engaged for advice and recommendations.

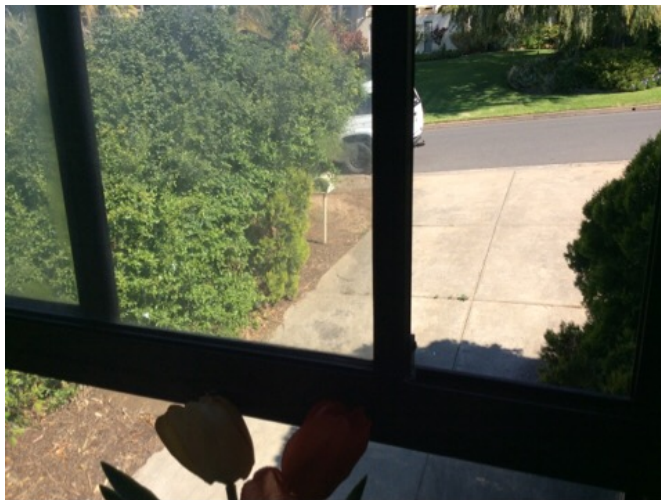
No Flyscreens present.

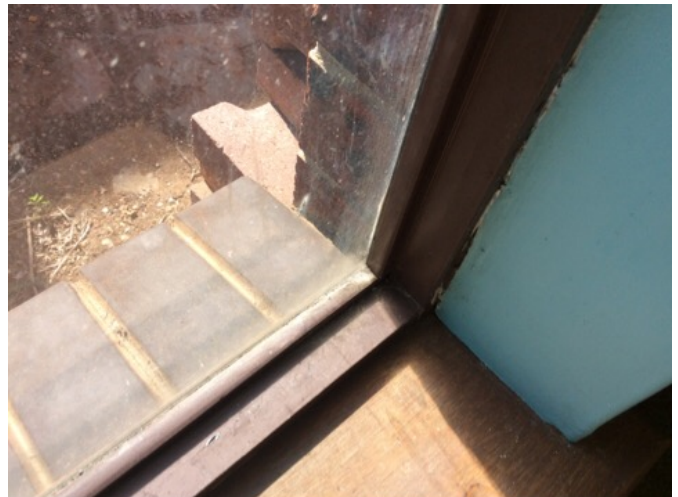
General age wear deterioration - The window frame/components showed evidence of ageing and wear. Recommendations: General maintenance works required.

Moisture damage and high moisture readings recorded. Possible water ingress. Or condensation. Contact a glazier for repairs.

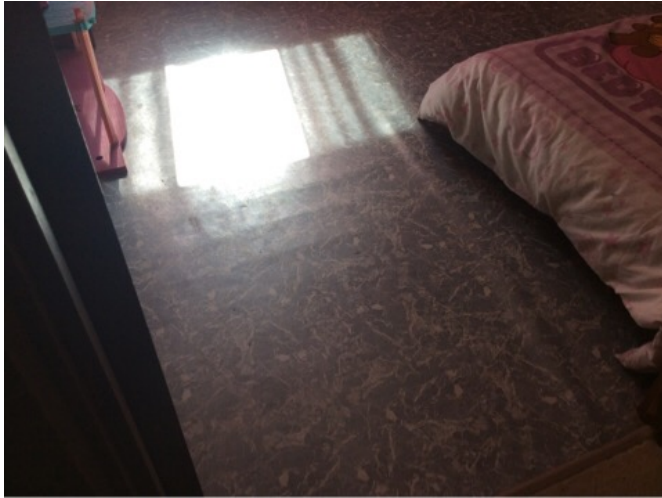
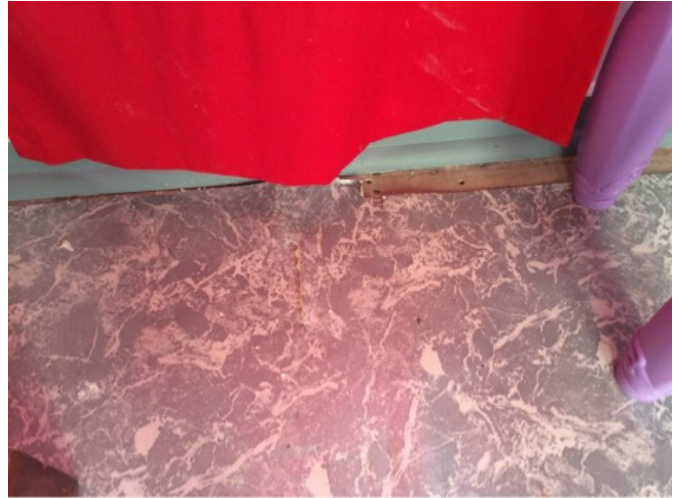
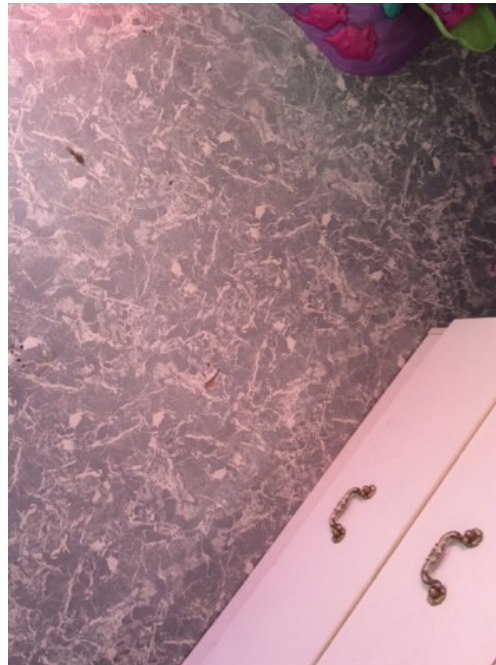
Unevenness visible in floor - Recommendations: A qualified carpenter should be engaged for advice and recommendations re levelling. Vinyl has been loose layed and stapled on ends. Quite poor, bubbles in areas. Damage to sections.

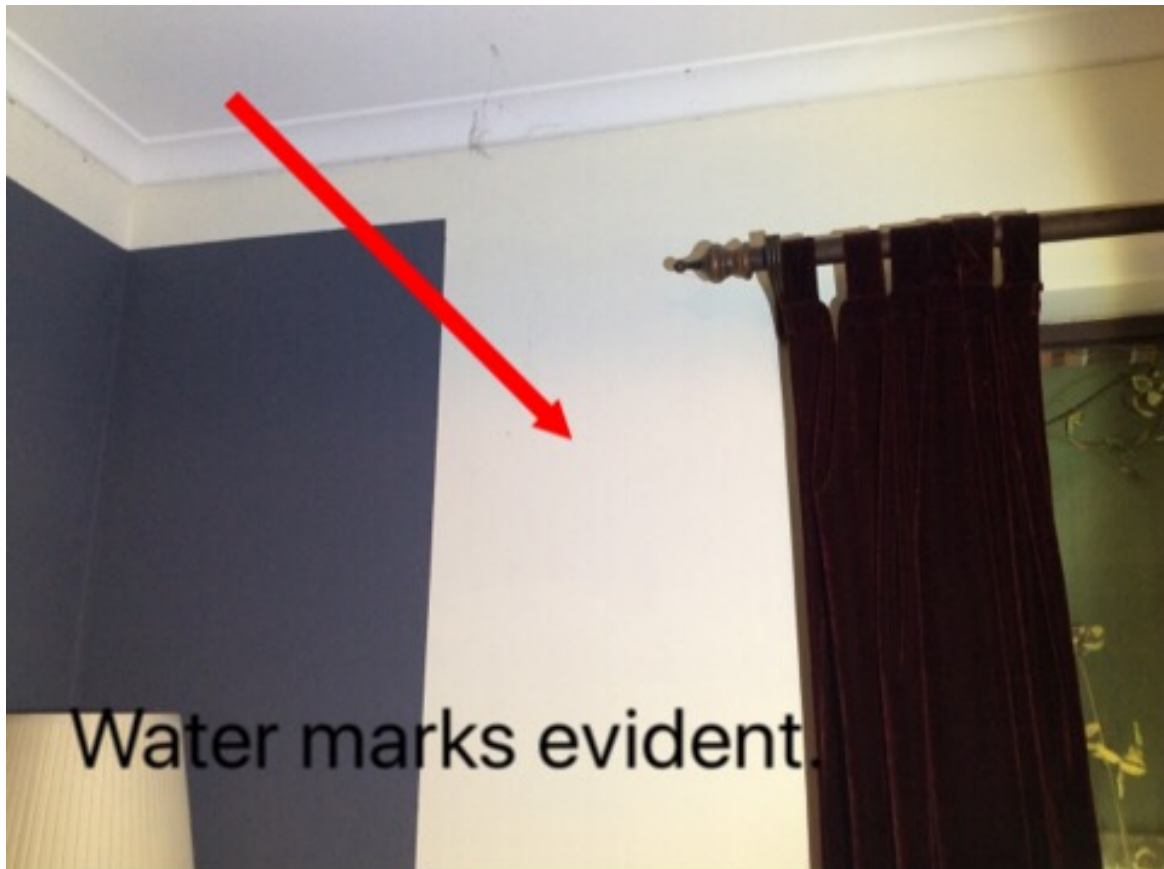
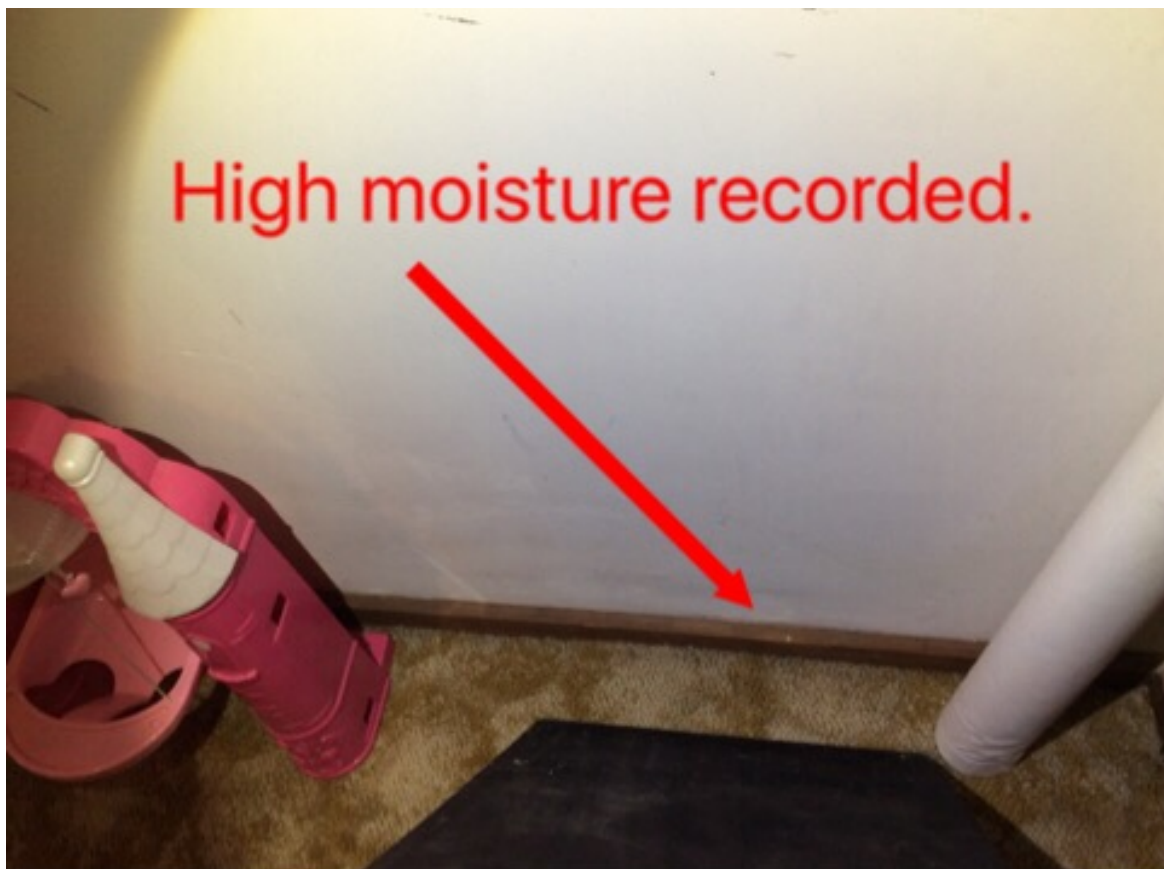
Excess moisture readings were obtained on the wall linings adjacent bathroom/shower. This may be related to the shower recess/plumbing in wall cavity leaking or failed waterproofing membrane to the wet area. Recommendations: Engage a plumber and a licensed waterproofer for advice and recommendations.

Water stains down wall, minor but suggests water has entered, check roofing and gutters.

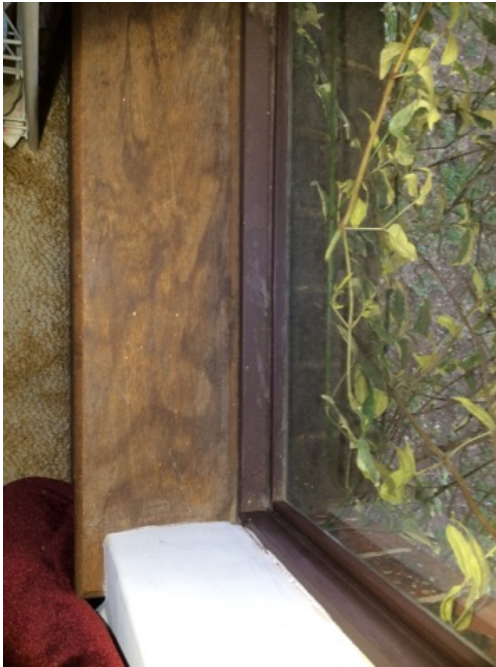
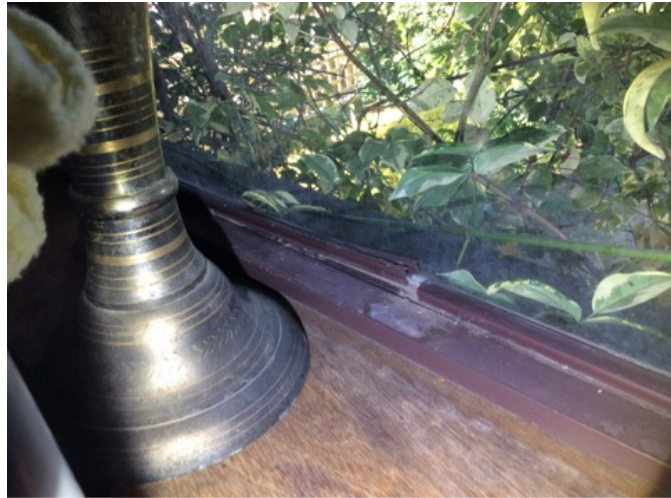
Moisture damage and high moisture readings recorded. Possible water ingress. Or condensation. Contact a glazier for repairs.

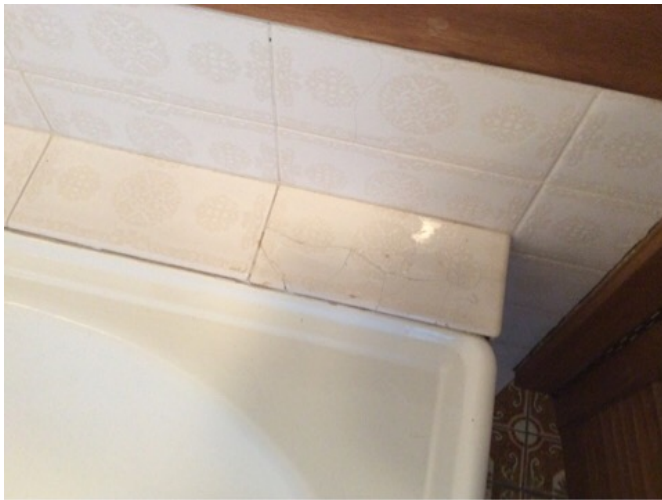
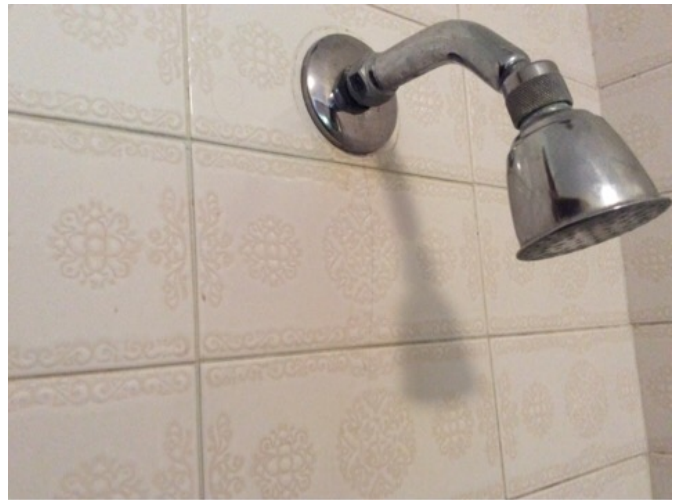
Damaged tile/s observed . Have repaired by a licensed tiler. Seal openings around bath.

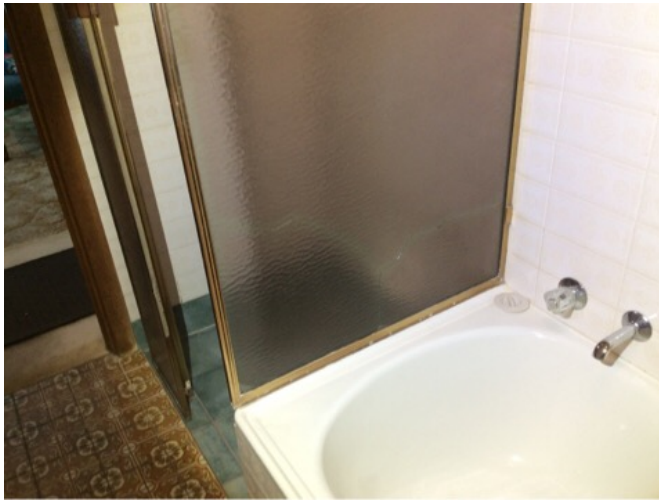
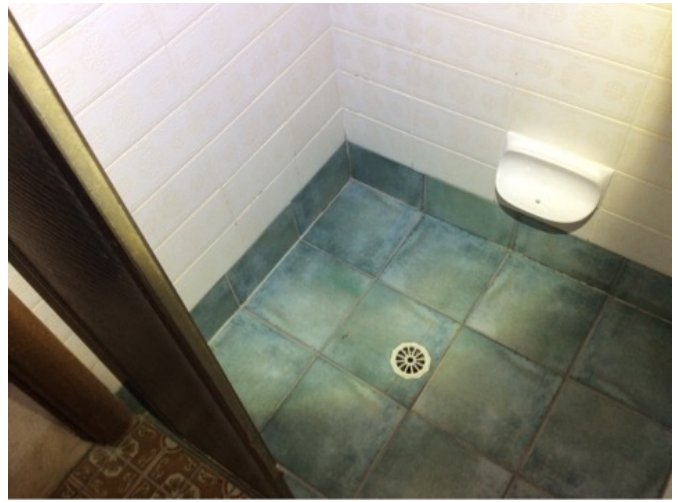
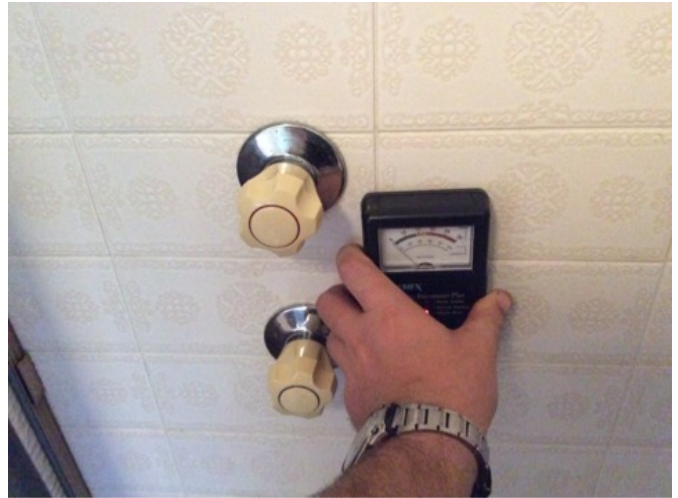
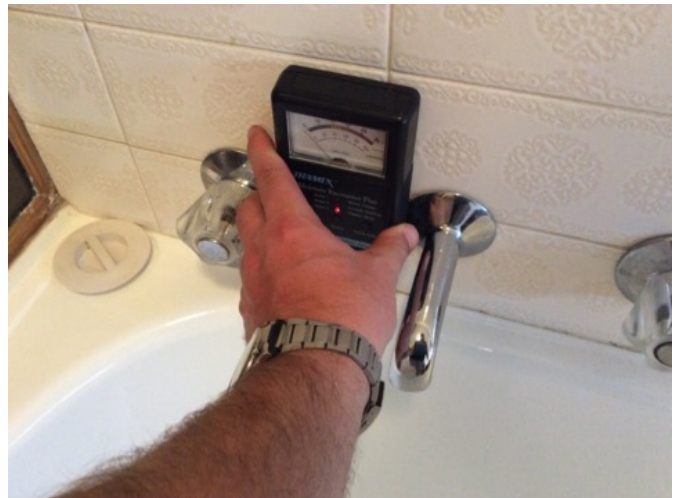
Cracked shower screen - Replacement required.

Silicon work requires renewal at base of shower. High moisture content at base of shower, high moisture on adjoining wall, see bedroom 5 walls.

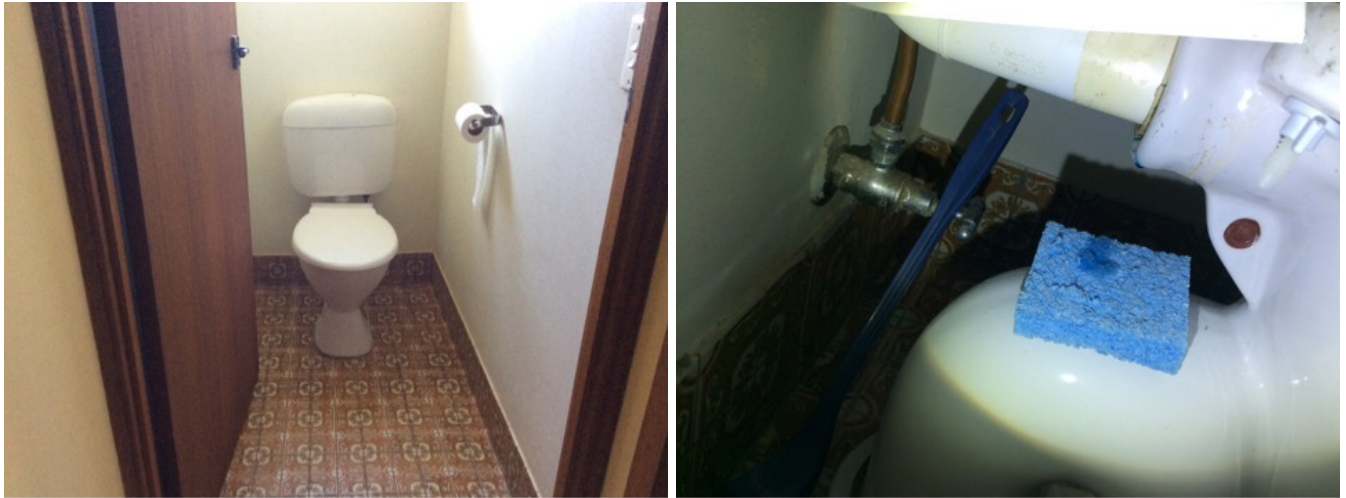
The cistern is leaking and should be repaired. Contact a licensed plumber for repairs.
Pan is loose at the base. Contact a licensed plumber for repairs.

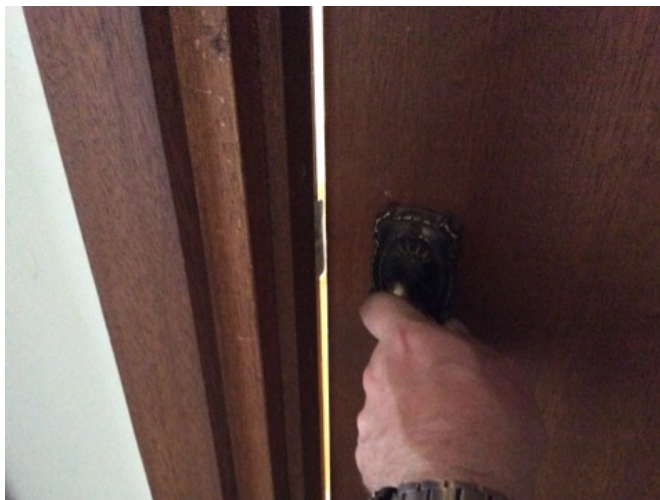
Binding door - Doors that bind on the frame can relate to some differential settlement in the footings, frame movement, age, expansion, shrinkage and the like. It can also be seasonal where it may bind for some months and then open and close sufficiently. Monitoring over time or a more invasive inspection is only method of ascertain cause. Recommendations: A qualified carpenter should be engaged for advice and recommendations. Extremely poor fit to door.

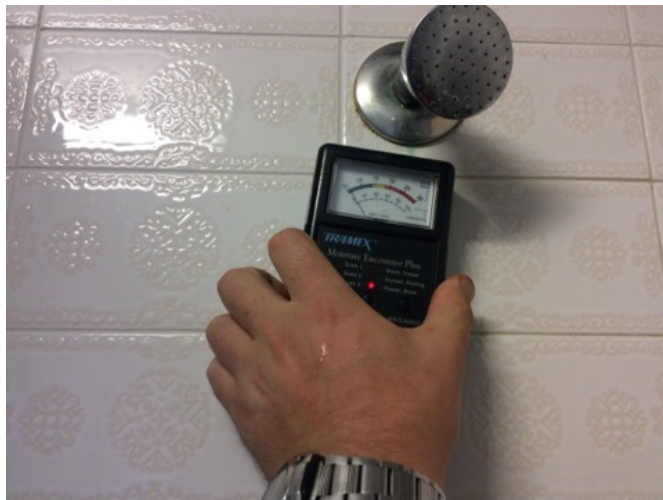
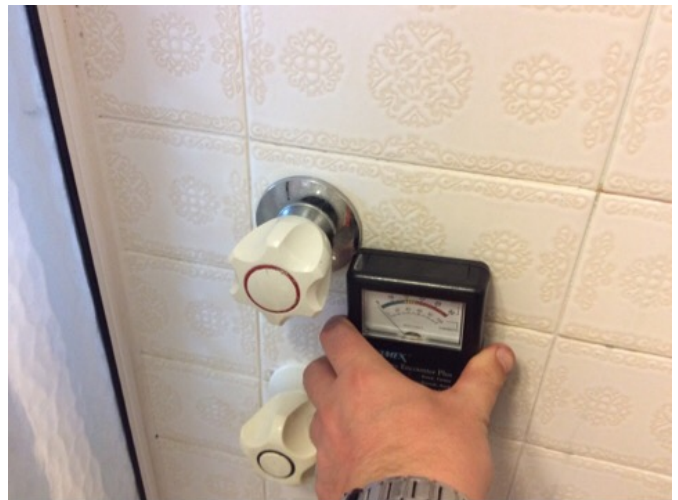
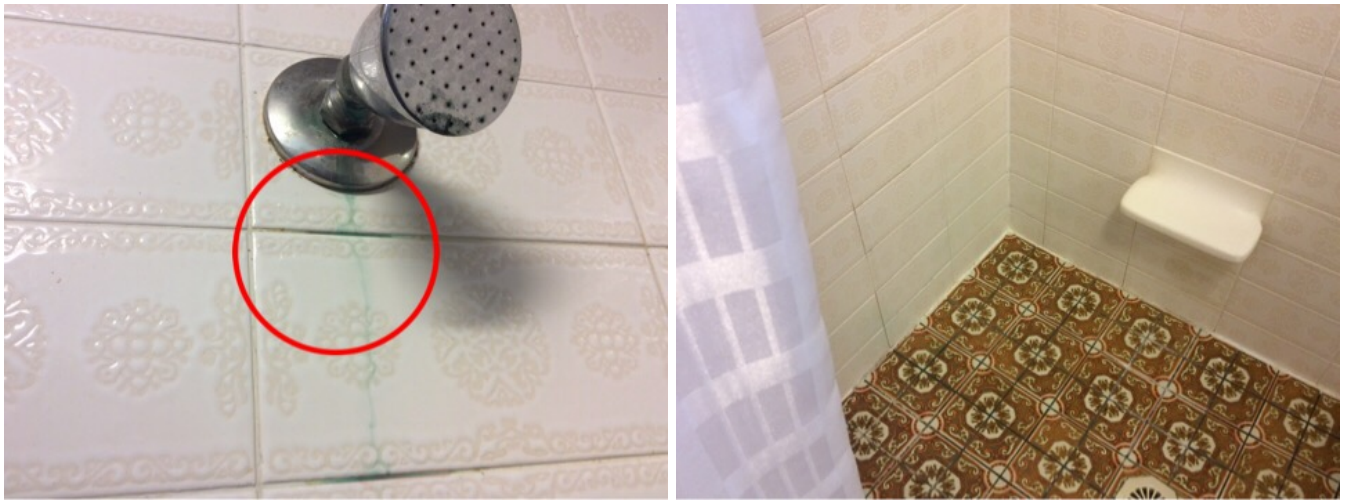
Shower head is leaking. A qualified plumber should be engaged for advice and recommendations.

No high moisture content recorded at the time of inspection. Sealant at base of shower requires renewal.

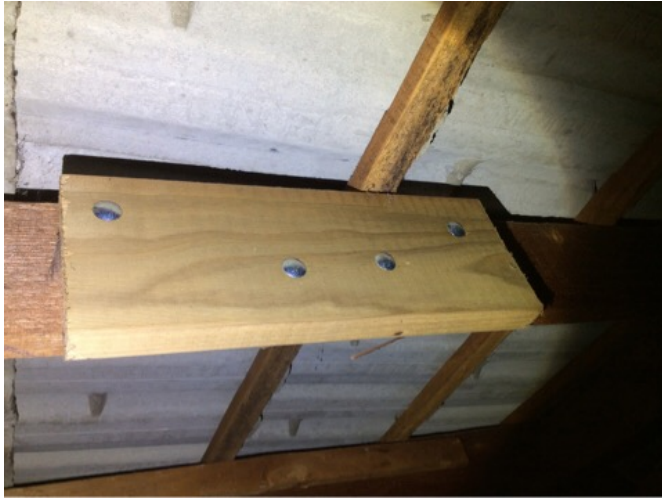
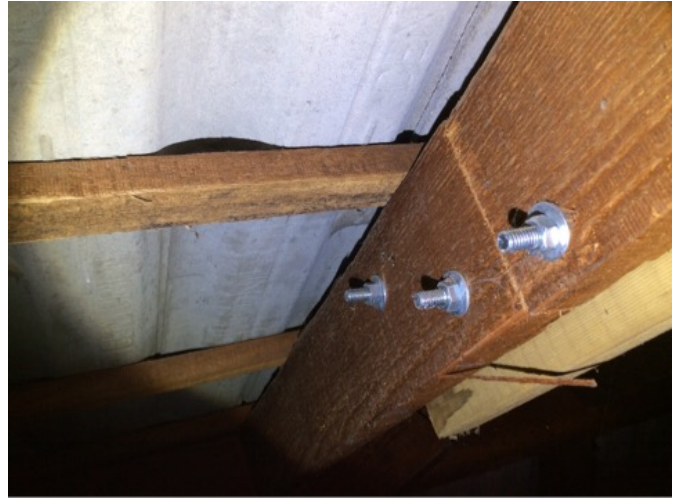
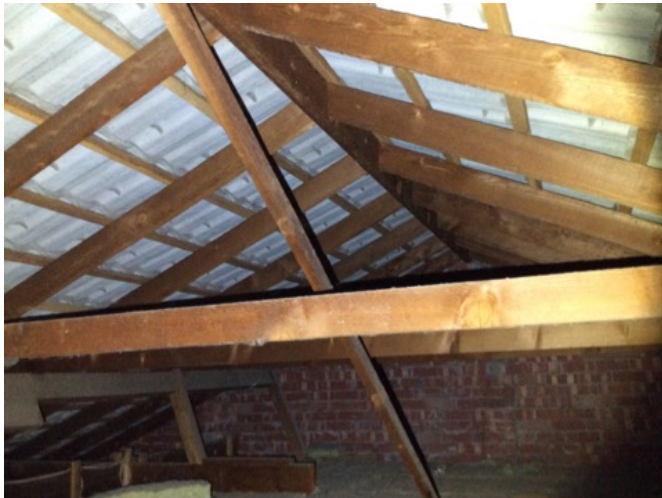
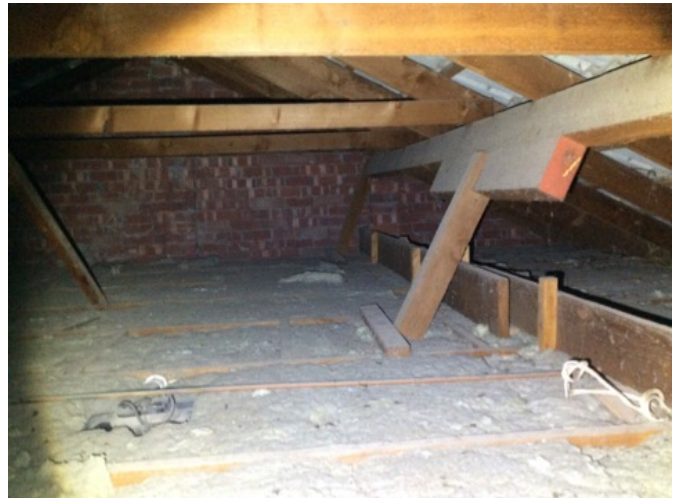
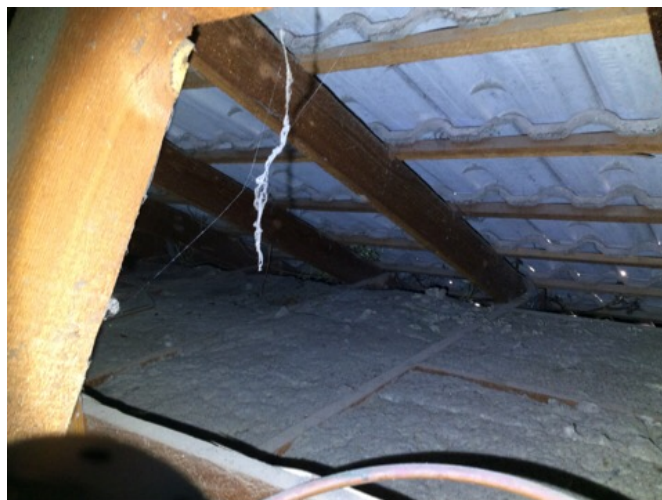
Visible sections of the roof void is in a serviceable condition for age of this dwelling. A rafter had been cut but has been graced with an additional member and bolted through. Appears to be performing adequately.

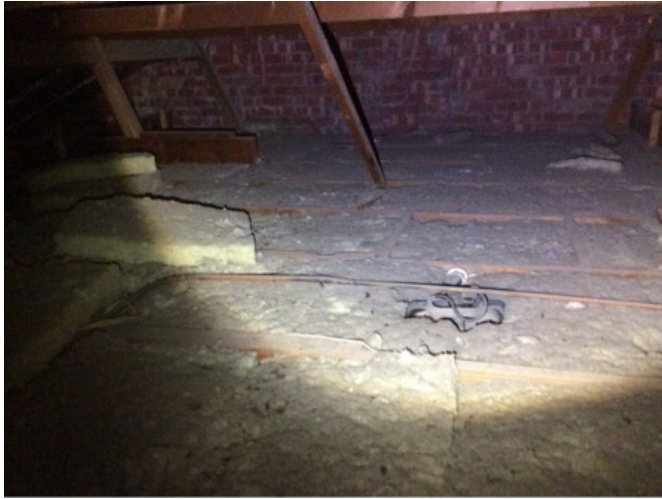
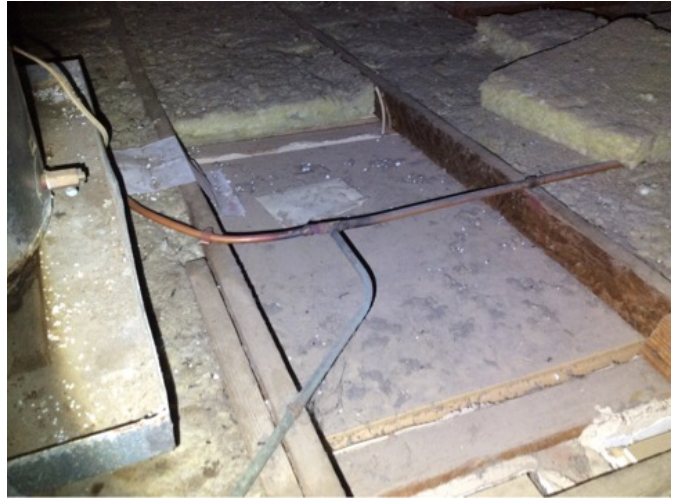
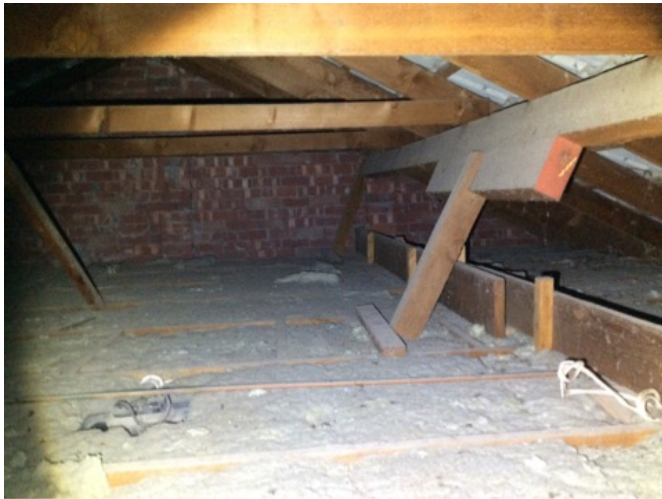
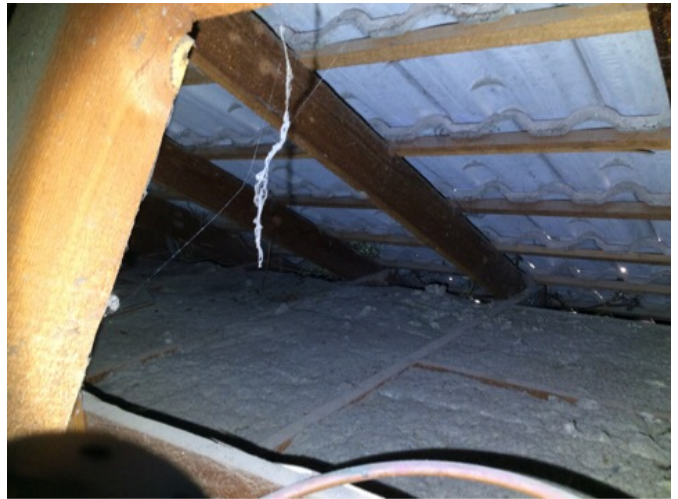
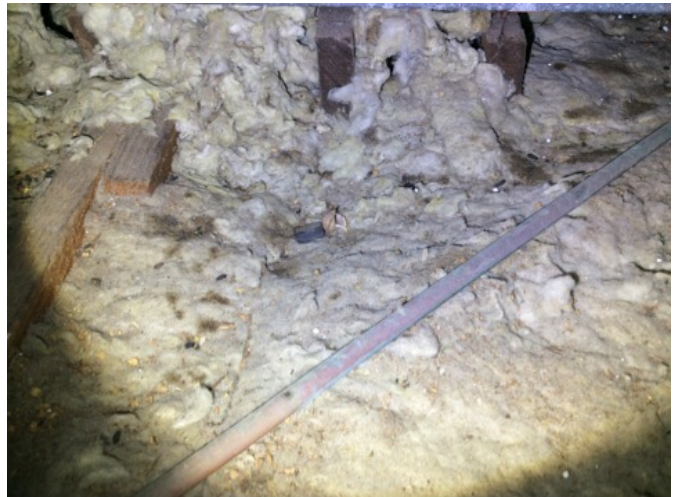
The roof space is insulated with fibreglass batts. A few gaps, only minor.

Where visible and accessible, the insulation appears to be in a serviceable condition.
Rodent droppings evident. Recommend a rodent treatment is carried out immediately.
Contact our office if you require further assistance.
