Inspection Report

Homemasters Building And Pest Inspections

Sample Report Street Adelaide, sample

Pest And Building Inspection

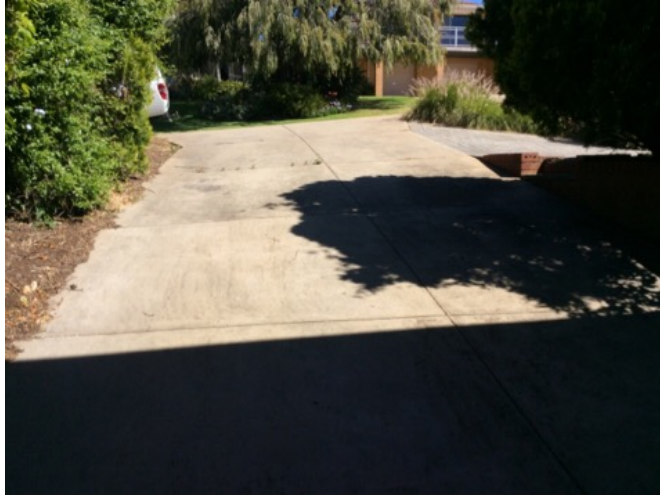
Driveway Condition

On visual inspection, the general condition of the driveway is in a serviceable condition.

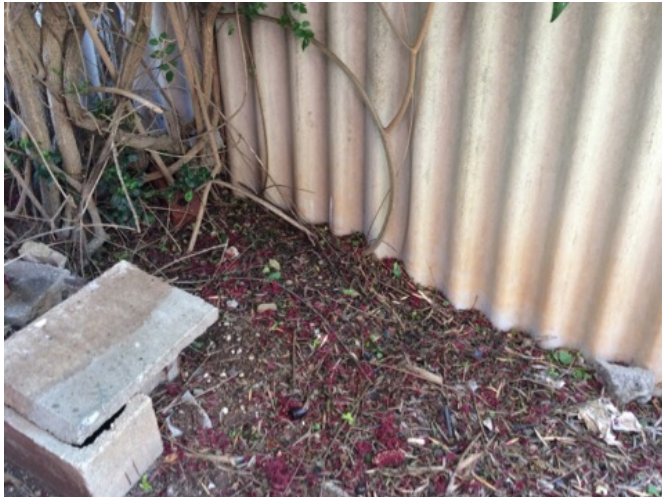
Fences & Gates

On inspection, defects were present that will require further accessing and recommendations by licensed and qualified trades persons.

Vines present, recommend immediate removal as this can cause additional stress to panels and cause early failure. Vines may also be holding up sections of fencing, some leaning to areas is present.

Dirt against panels, recommend immediately removing any soil against the panels to help prevent early deterioration/rust. Fencing should not be used to retain soil, ideally a small plinth or retaining wall should have been installed to areas as required and the fence installed on top of that. All vines should be removed so a store complete inspection can be undertaken.

Rear and right hand side fencing is asbestos. Consult an asbestos specialist for advice and recommendations. Some damage to panels as can be seen in the last photo.

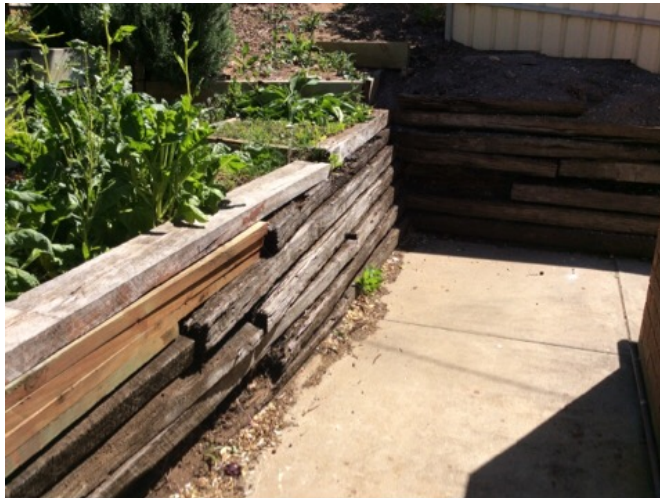
Retaining Walls

Timber fungal decay evident. Recommendations: A qualified landscaping contractor should be engaged for repairs and recommendations. Ideally should be replaced with concrete.

Termite damage noted. We recommend you contact a licensed pest controller for further assessment, treatment and eradication in accord with AS3660.2

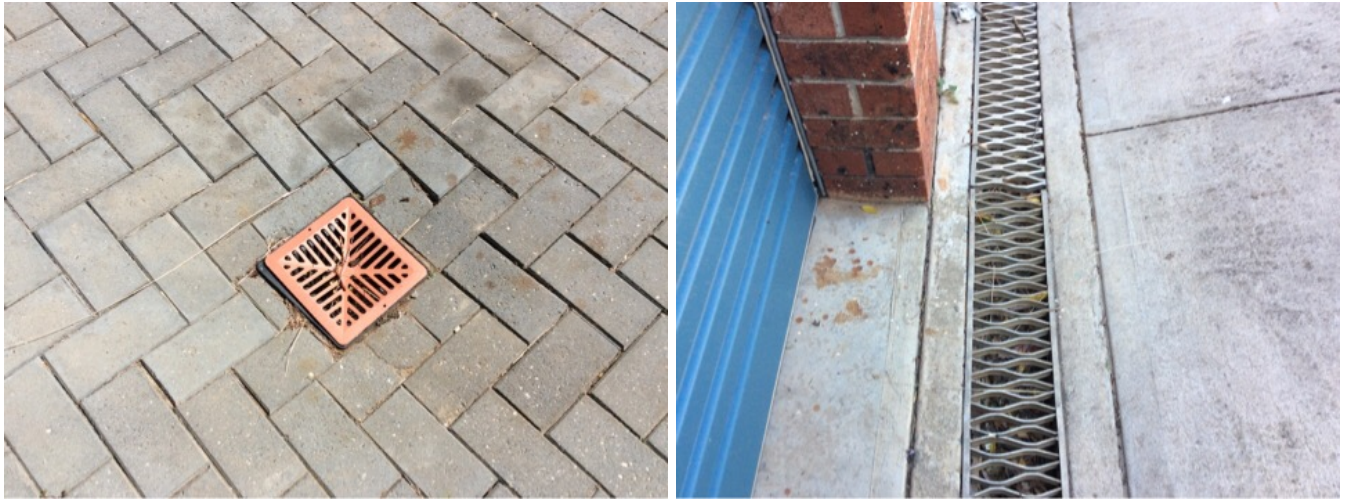
Drains

Debris evident in/around drains - Requires cleaning out.

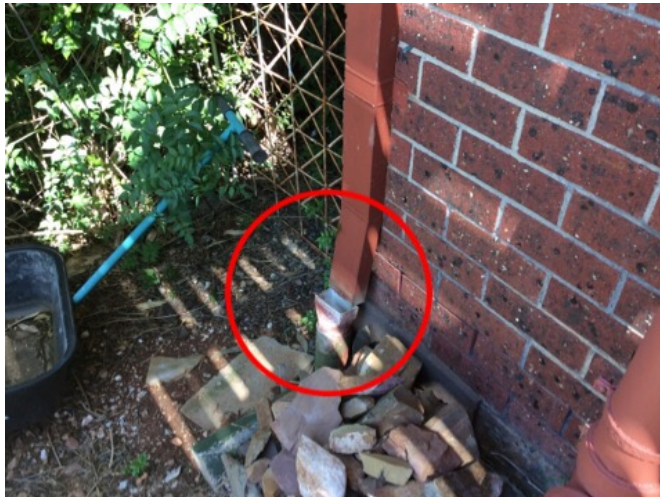
The down pipe base is inadequately aligned at ground pipe. This has the potential to cause debris blockage. Recommendations: A qualified plumber should be engaged for repairs and recommendations.

Leaking down pipe joins visible. This can be conducive to termite infestation and cause water damage to cladding over time. Recommendations: A qualified roof plumber should be engaged to repair.

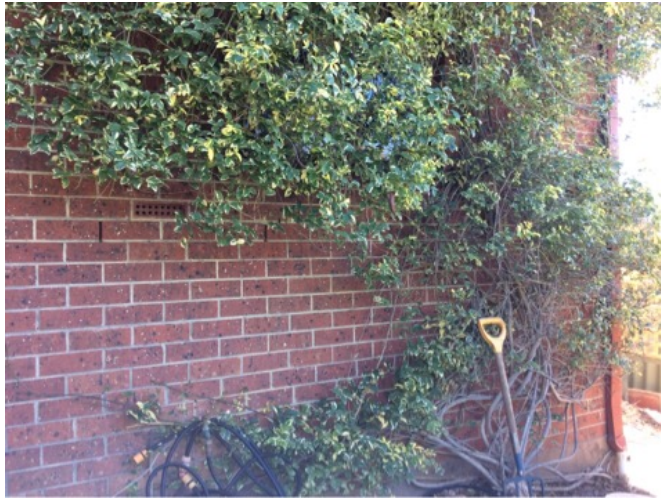
Exterior Walls

Wasps nest noted under front porch area, consult a pest technician for treatment.

Area where old air conditioner would of been has been poorly boarded up. May allow water entry. Rectify. Remove all vine growth to the walls immediately.

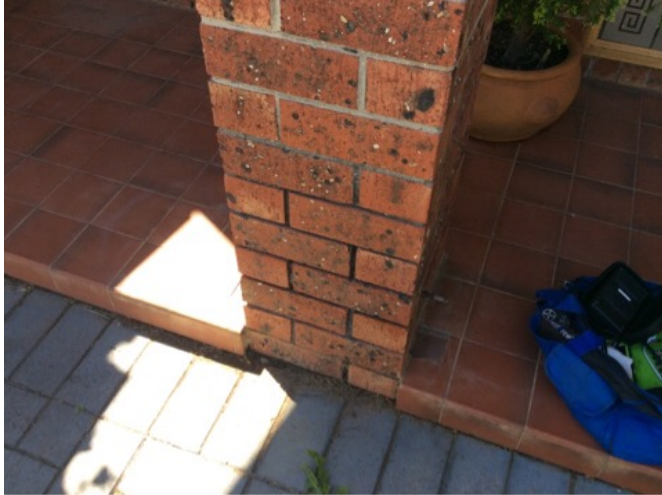
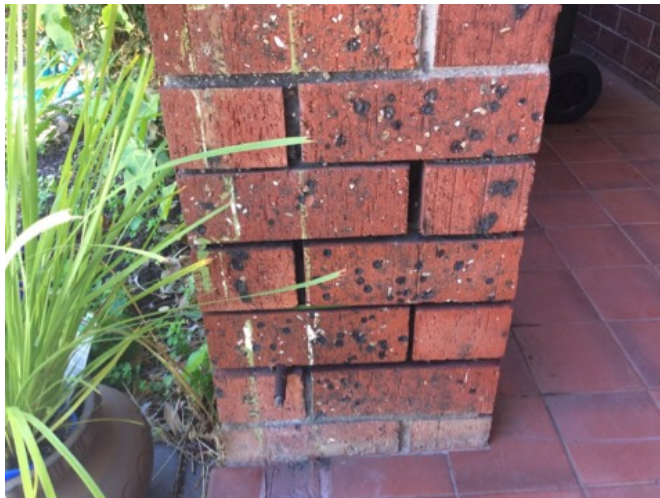
Rising Damp Findings

High moisture readings were to the exterior walls, support columns and front wall. We recommend a damp proof course specialist be engaged for further evaluation and repairs. Fretting if mortar was evident. No major deterioration to bricks was observed.

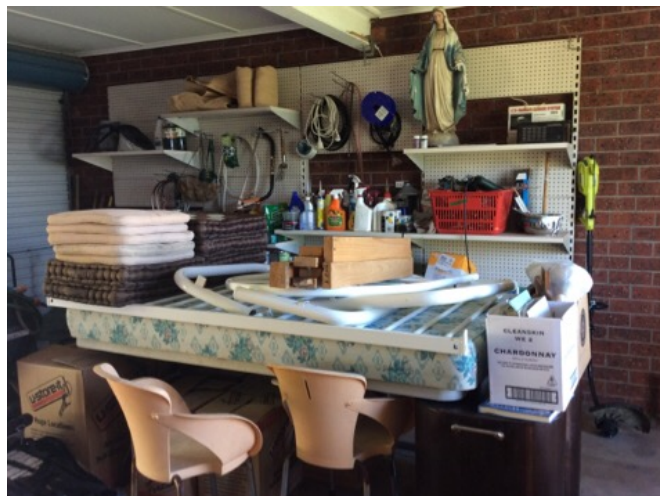
Areas Restricted

Storage items restricted a full and thorough inspection of this area. Defects may exist in the inaccessible areas. It is strongly recommended that full access be granted to enable a thorough inspection as there may be timber pest activity, damage or defects. Note: Where vehicles and storage has restricted a full inspection it is advised that this area be cleared so a full and unobstructed inspection can be carried out.

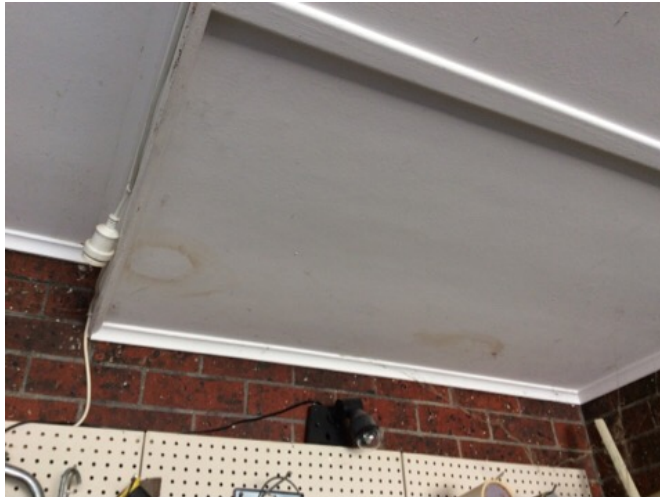
Ceiling Findings

Ceiling stains - No moisture readings obtained from same. Recommendations: These may have been repaired, however, you will need to monitor after a prolonged period of rainfall - If leaking persists, a qualified plumber should be engaged for advice and recommendations. It is strongly recommended that all water damaged plaster replaced by a qualified plasterer due to potential detachment or collapse. Considered a Safety Hazard

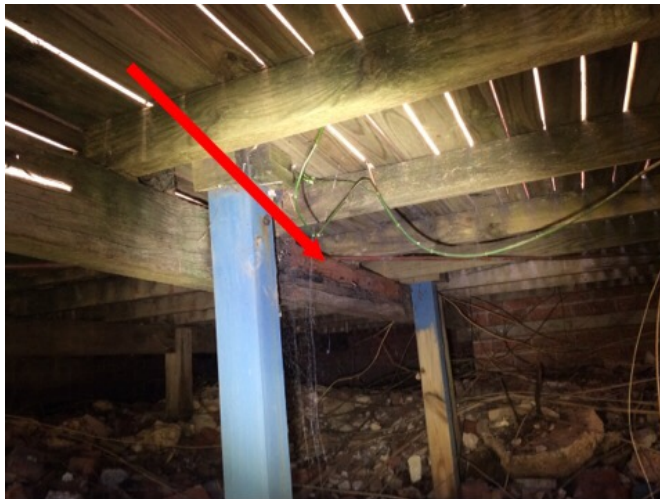
Deck Framework

Timber fungal decay in section of bearers or joists. This is a safety hazard and repair is required. Recommendations: A qualified carpenter should be engaged to replace all affected timbers.

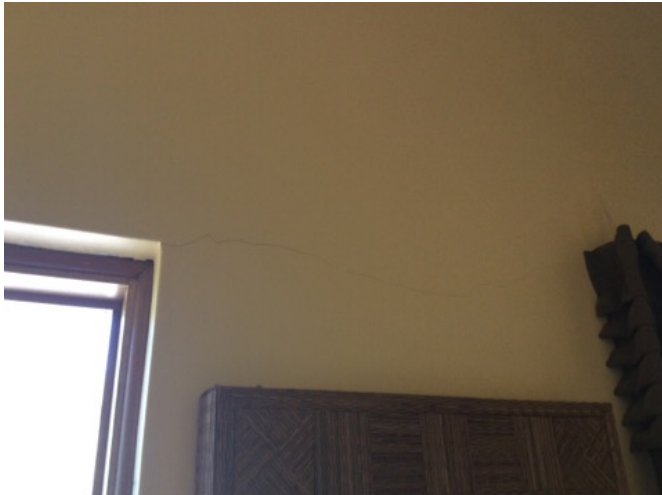
Settlement Cracks Noted. These are typical and generally patch and paint will suffice, however we recommend monitor these cracks and if become wider or longer, you will need to contact a structural engineers to assess.

Excess moisture readings were obtained on the wall linings adjacent bathroom/shower. This may be related to the shower recess/plumbing in wall cavity leaking or failed waterproofing membrane to the wet area. Recommendations: Engage a plumber and a licensed waterproofer for advice and recommendations.

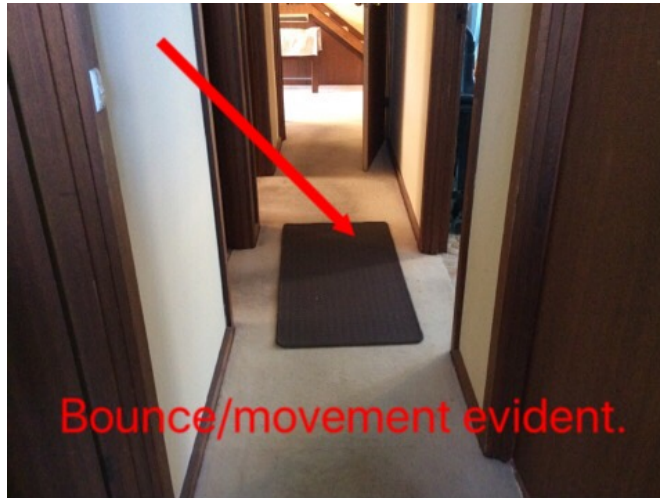
Flooring

Sponginess / bounce in hall flooring sections - Recommendations: A qualified carpenter should be engaged for advice and recommendations. The floor lining may require removal to assess and replacement of boards and framing members may be required.

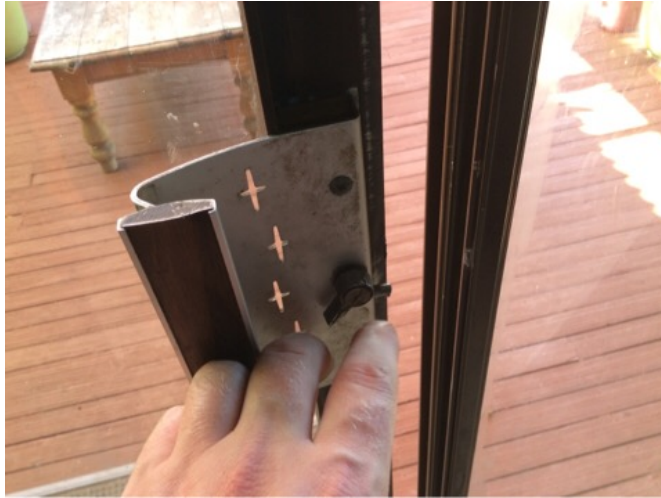
Door / frame deterioration - General age/damage has occurred to door frame, face or components. Recommendations: A qualified carpenter should be engaged for advice and recommendations.

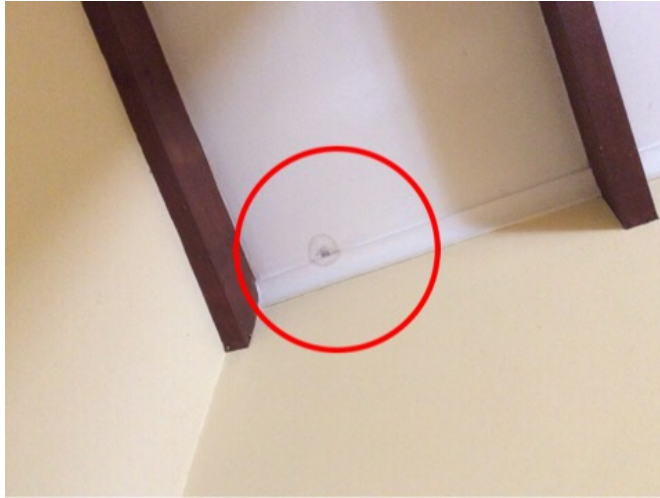
Ceiling stains - No moisture readings obtained. Recommendations: These may have been repaired, however, you will need to monitor after a prolonged period of rainfall - If leaking persists, a qualified plumber should be engaged for advice and recommendations. All water damaged plaster replaced by a qualified plasterer.

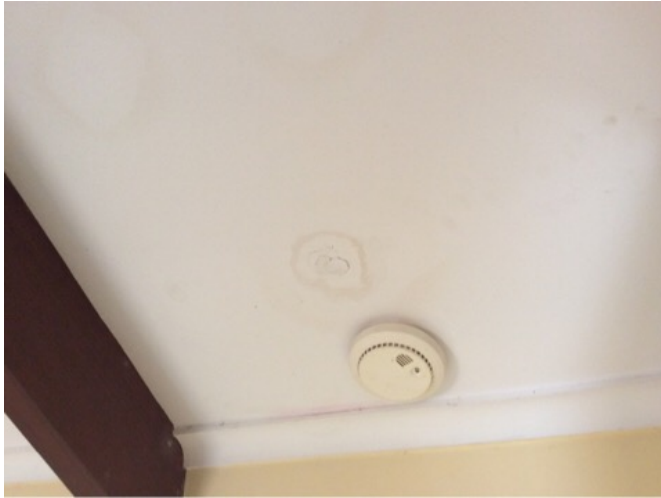
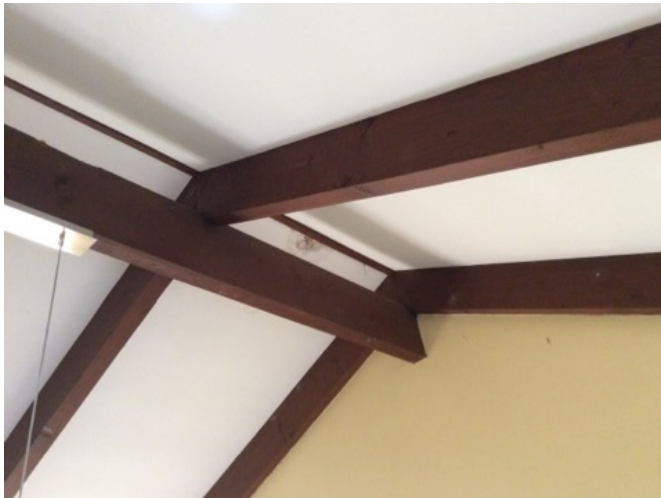
Ceiling stains - Moisture readings obtained. In the absence of rain It's difficult to ascertain with certainty the location of the leak. Recommendations: A qualified roofer should be engaged for advice and recommendations. All water damaged plaster should be replaced by a qualified plasterer.

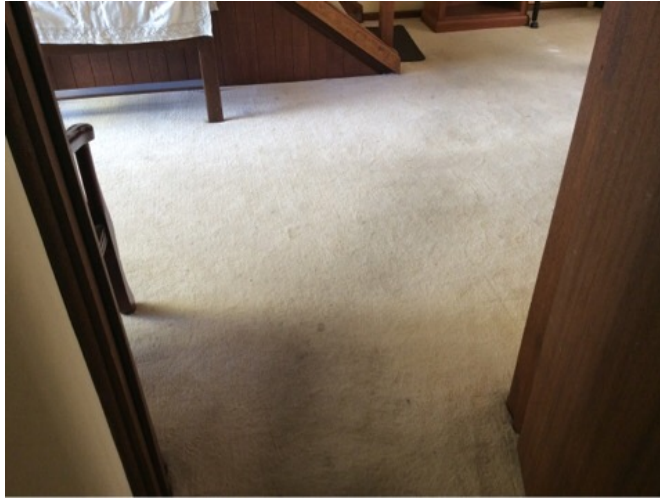
Flooring

Stains observed - Recommendations: Steam cleaning may rectify stained areas but they appear entrenched.

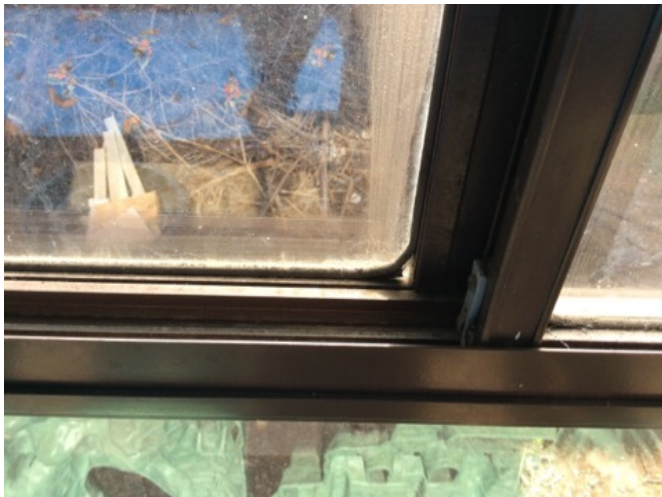
Windows

General age wear deterioration - The window frame/components showed evidence of ageing and wear. Recommendations: General maintenance works required.

Moisture damage and high moisture readings recorded. Possible water ingress. Or condensation. Contact a glazier for repairs.

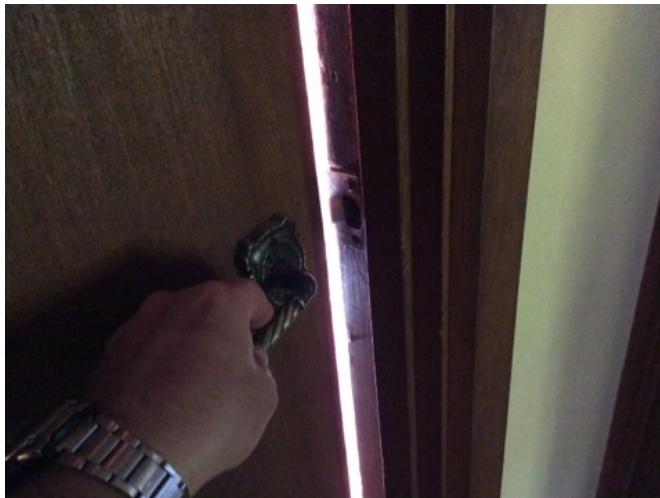
Door

Uneven / out of square door frame - This can relate to some differential settlement in the footings, frame movement, age, expansion, shrinkage and the like. Recommendations: A qualified carpenter should be engaged for advice and recommendations.

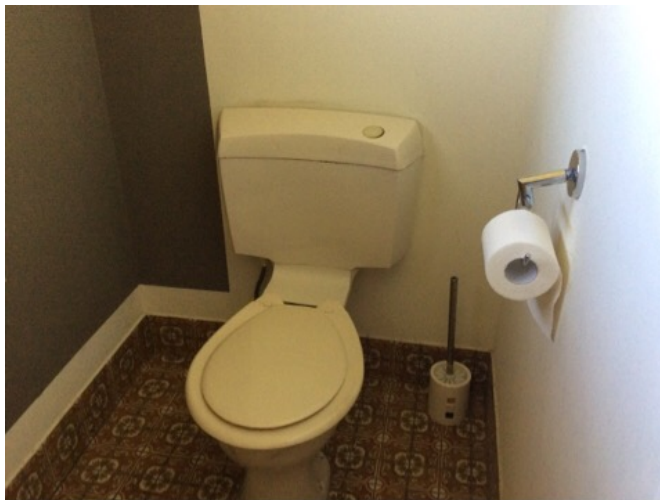
Toilet

Should be upgraded to a dual flush system.

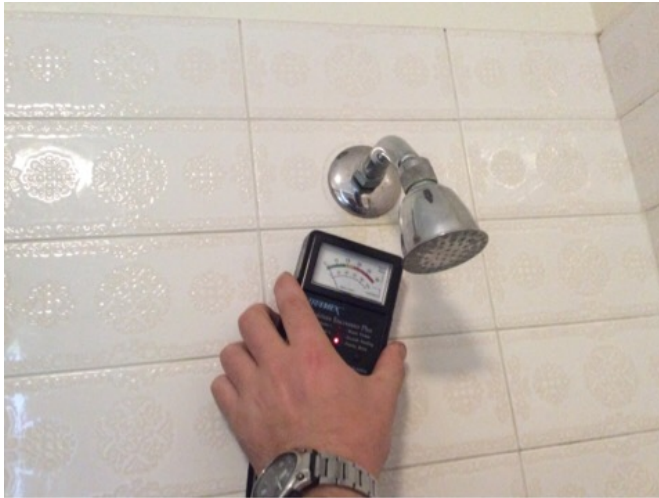
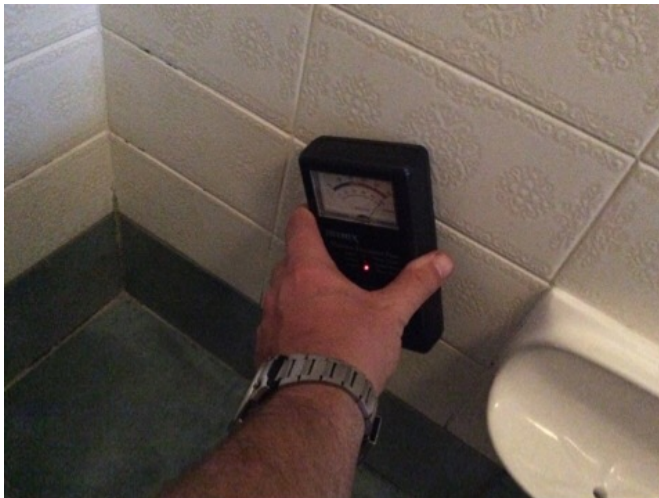
Cracked shower screen - Replacement required.

Silicon work requires renewal at base of shower. High moisture content at base of shower, high moisture on adjoining wall, see bedroom 5 walls.

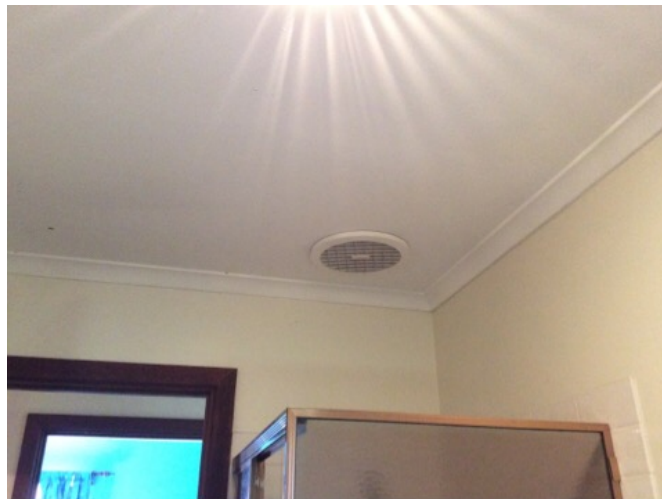
The exhaust fan is noisy - Have assessed by a qualified electrician.

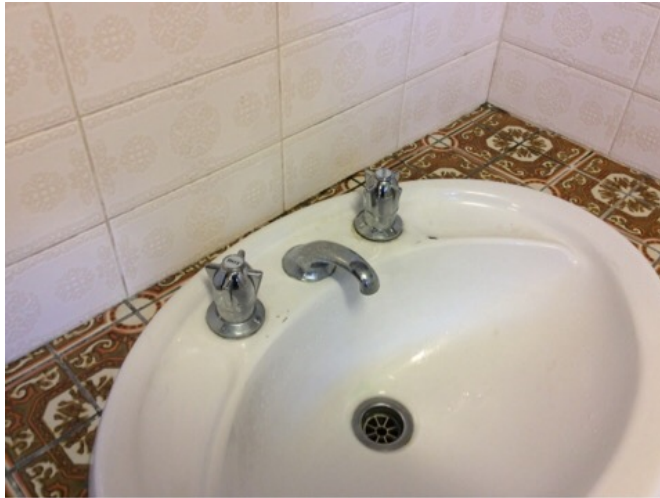
The taps are stiff to open. A qualified plumber should be engaged for advice and recommendations. Normally replacing spindles will rectify.

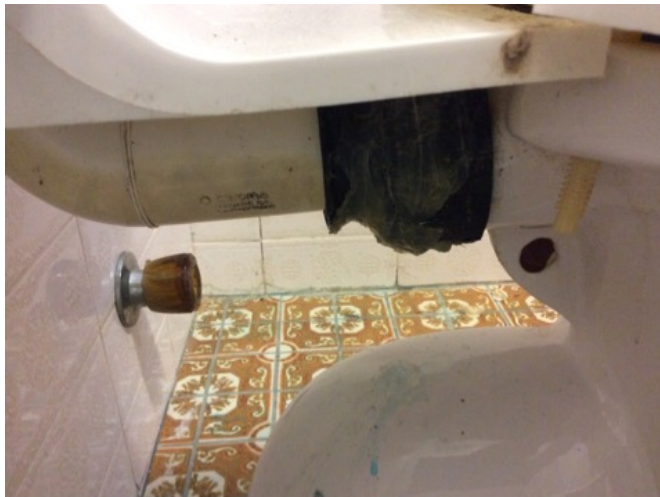
The cistern is leaking and should be repaired. Contact a licensed plumber for repairs. Seal at rear requires replacement, leaking.

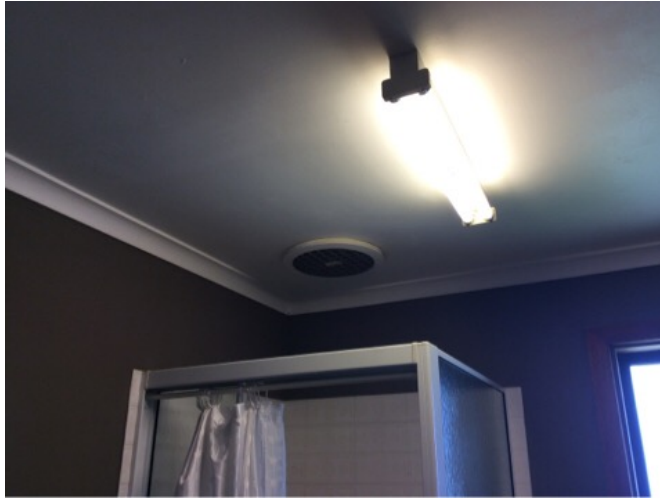
Exhaust fan is installed but not operable. A qualified electrician should be engaged for advice and recommendations

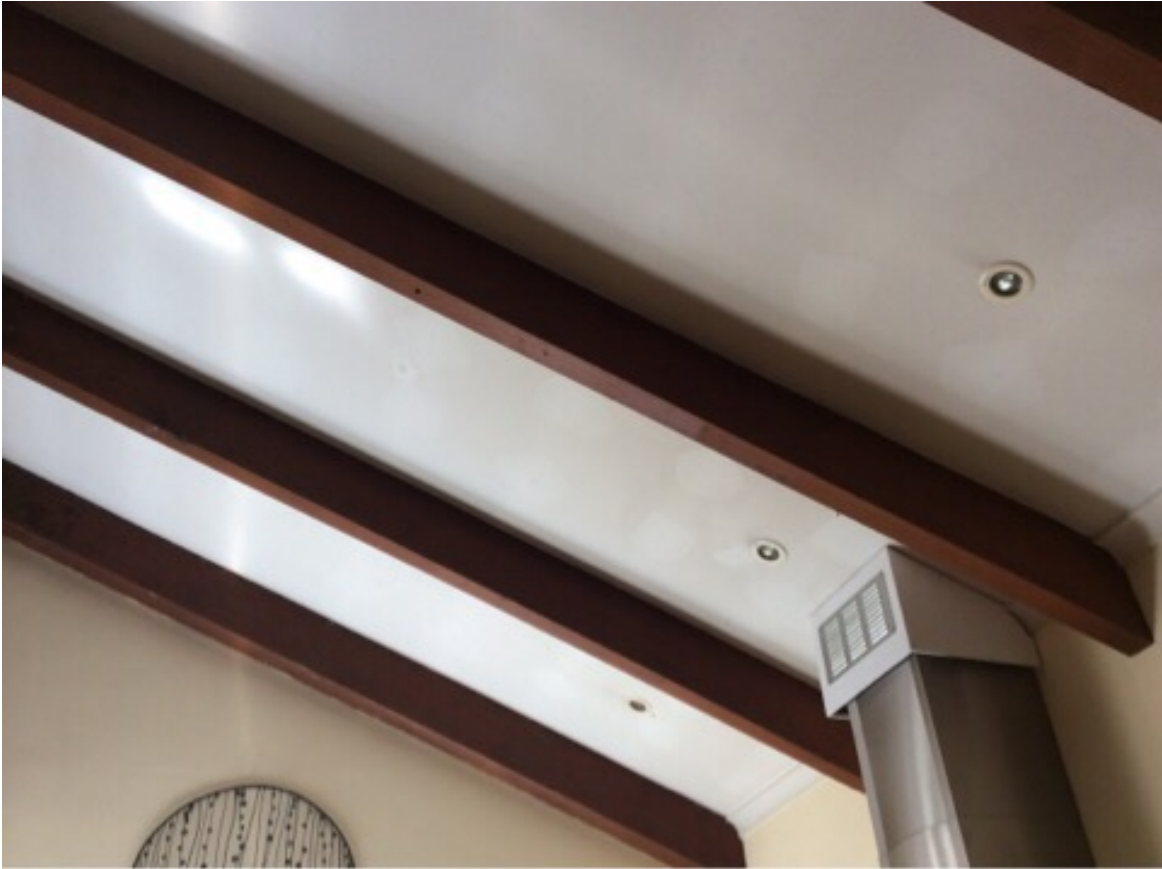
Nail heads have been patched and require painting.

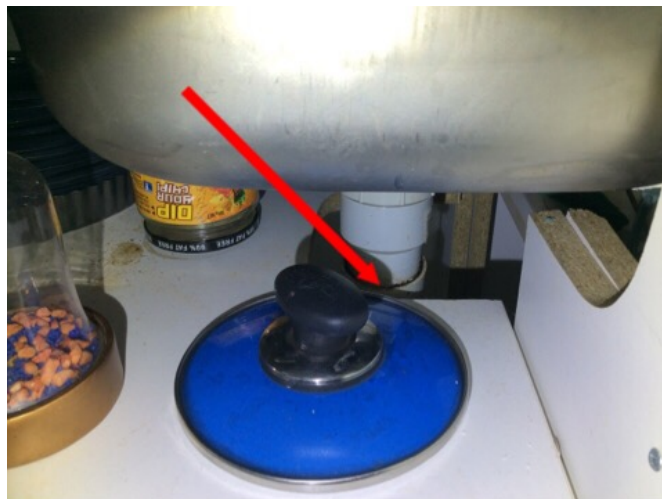
Pipe not properly attached, consult a plumber to adequately fix.

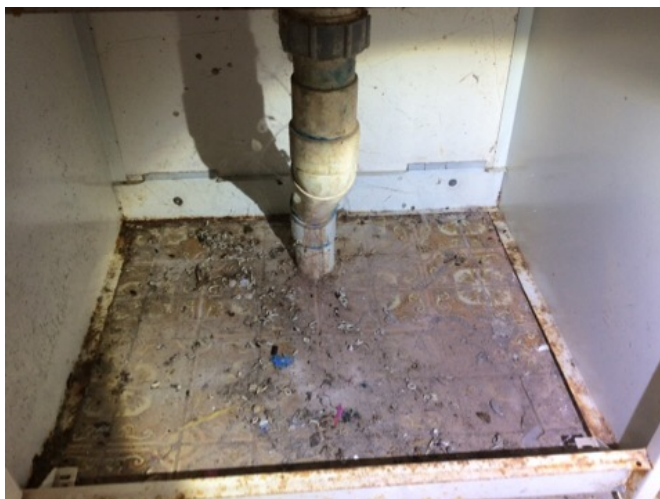
Rodent droppings noted under laundry trough. Recommend treatment.

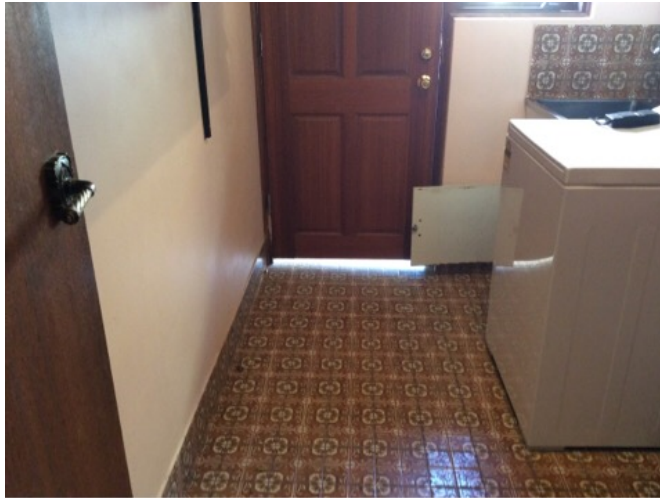
Large gap will allow air to flow, refit new door or add a raven seal.

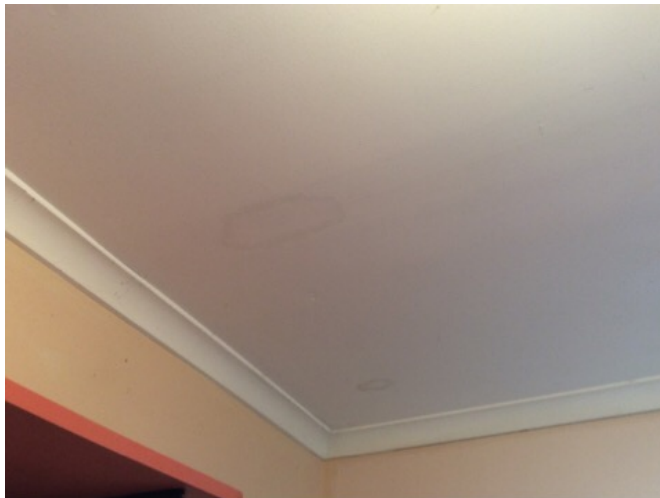
Ceiling stains - No moisture readings obtained from same. Recommendations: These may have been repaired, however, you will need to monitor after a prolonged period of rainfall - If leaking persists, a qualified plumber should be engaged for advice and recommendations. Essentially, it is preferable to have all water damaged plaster replaced by a qualified plasterer due to potential detachment or collapse.

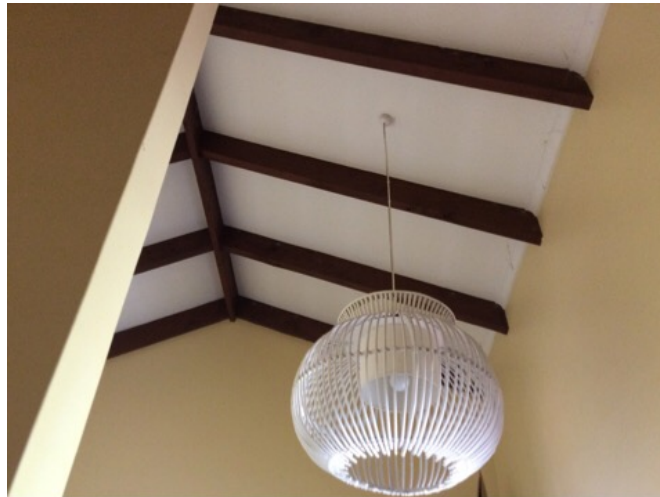
Cathedral ceiling design - No crawl space. It is strongly recommended that full access be gained as it could be harbouring timber pest activity, damage or defects.

There is insulation present in the roof space/void. This is preventing a full inspection of ceiling joists from being undertaken. It is strongly recommended that full access be gained as it could be harbouring timber pest activity, damage or defects.

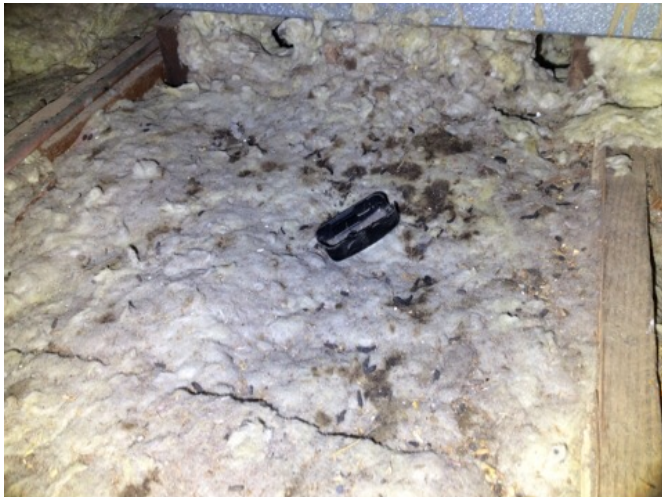
The roof space is insulated with fibreglass batts. A few gaps, only minor.

Where visible and accessible, the insulation appears to be in a serviceable condition.
Rodent droppings evident. Recommend a rodent treatment is carried out immediately.
Contact our office if you require further assistance.

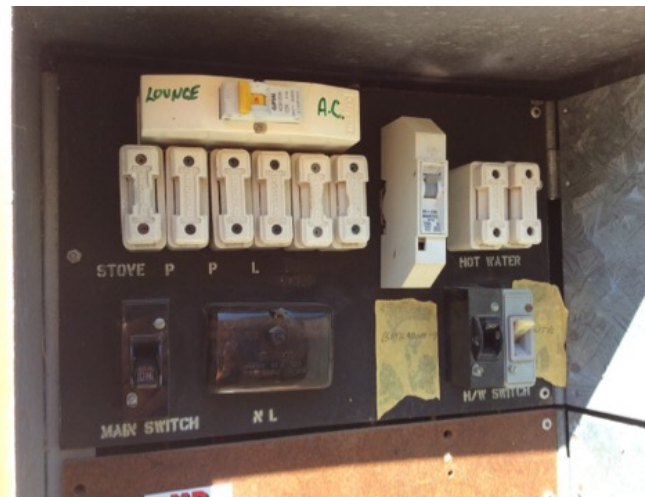
Older style ceramic fuses still in place. An electrician should be consulted for advice in relation to upgrading the board. Older style wiring may still be present in the home.

Bathroom and ensuite switches in off position. We do not flick switches, ensure there are no problems and the switches were not tripped. They also may not be in use, please check and ensure there are no problems.
